# **Assessment of Tile Drainage System Impacts to Lake Champlain and Phosphorus Loads in Tile Drainage in the Jewett Brook Watershed of St. Albans Bay**

Date: December 21, 2017

Conference/Venue: Tile Drain Advisory Group Meeting

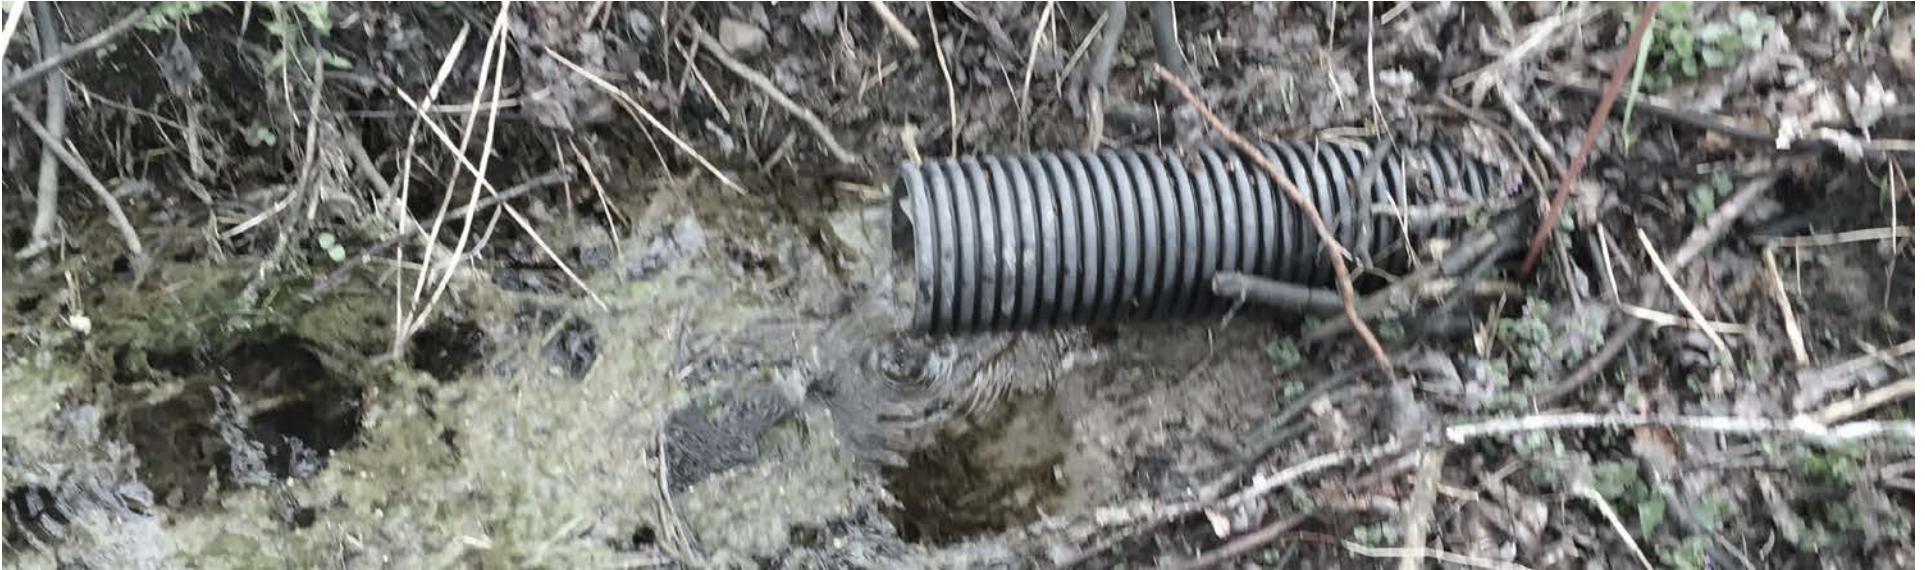
# Tile Drainage System Construction

- All 12 systems selected are standard, perforated, corrugated drain pipe.
- Most were installed within the last decade.
- The outfalls range in diameter from 4–12 inches.
- 9 of the 12 tile drains discharge to ditches. The 3 remaining (JBT01, JBT02, and JBT04) discharge directly to Jewett Brook.
- The tile drains range from 3–5 feet below ground, with most in the 3–4 feet range.
- All study fields have patterned drainage except JBT16, which has a dendritic (branching) system.
- Drain spacing is in the typical range of 25–40 feet, with the exception of JBT18 and JBT19, which have 80-foot spacing.

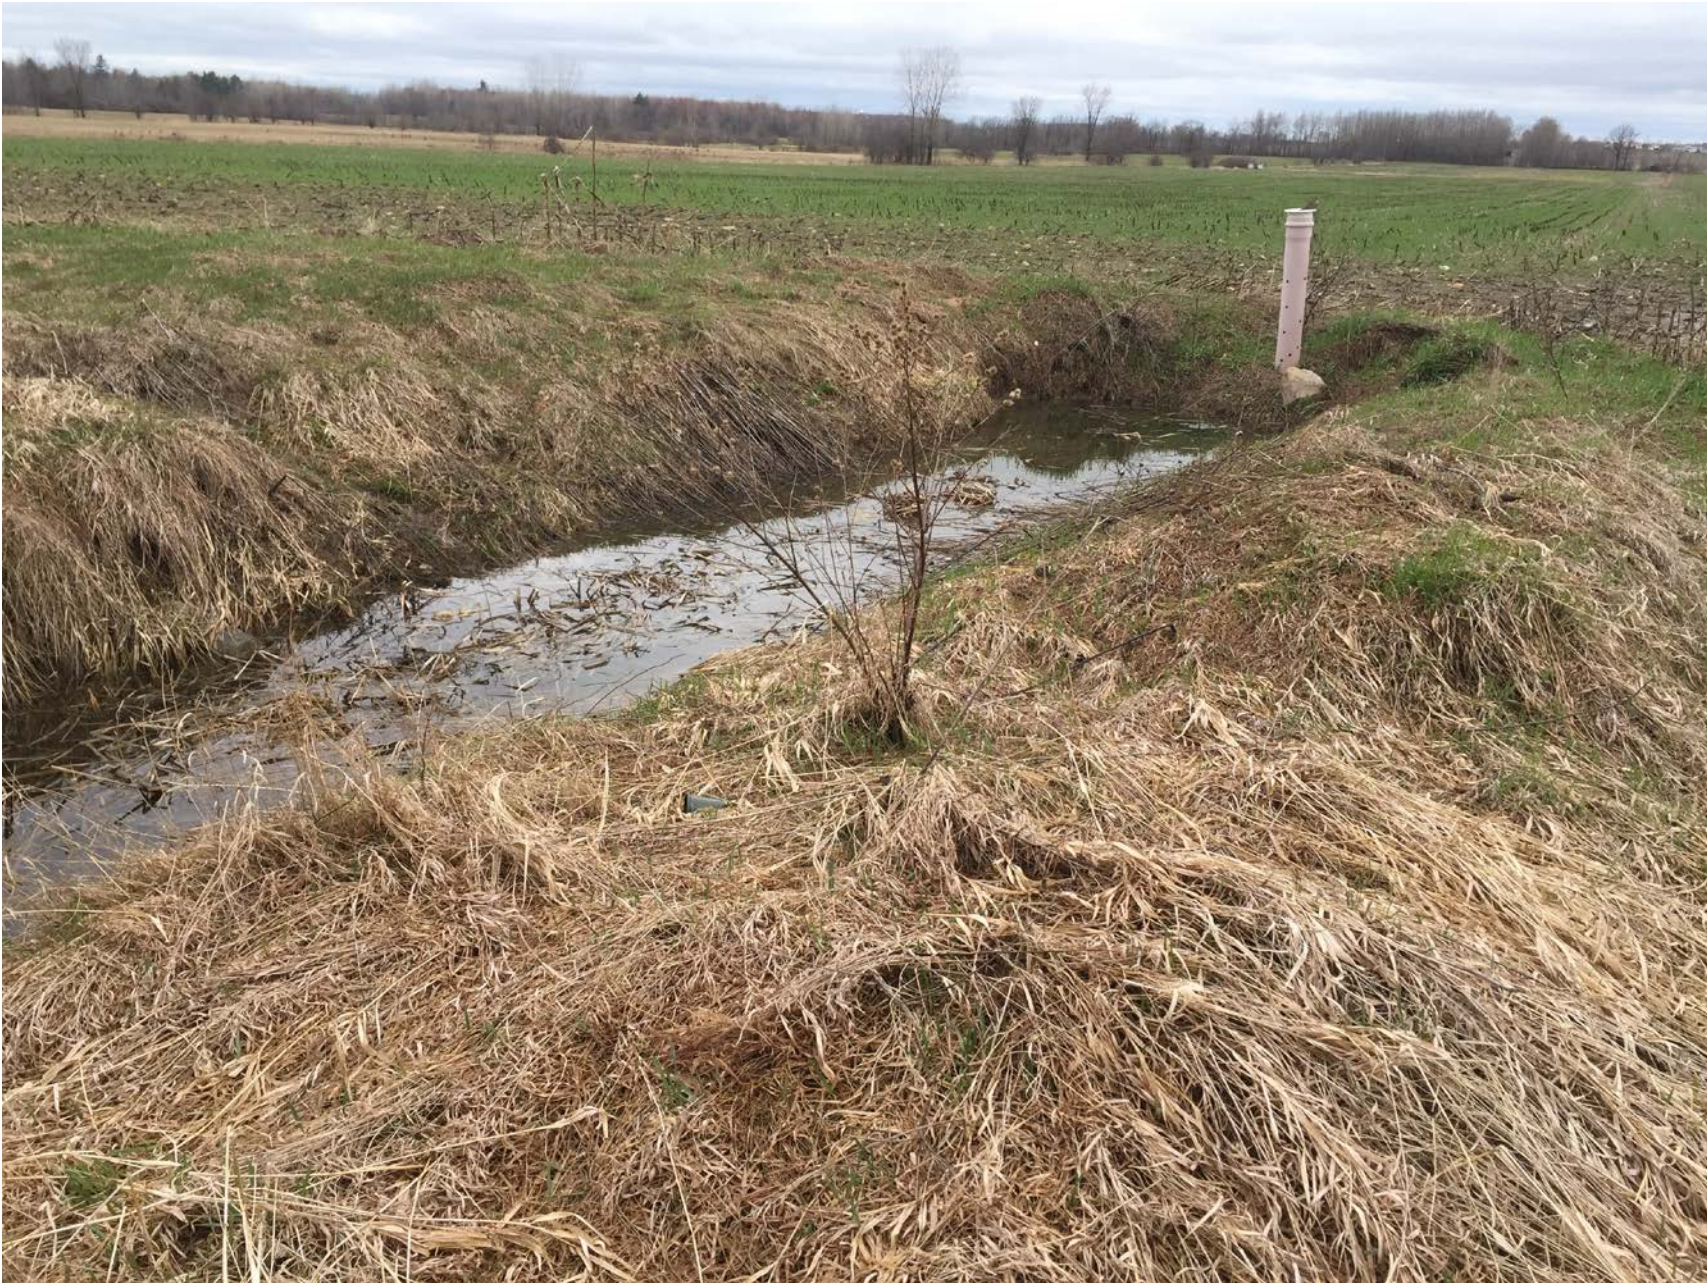
# Standpipe Inlet to JBT14 Tile Drain

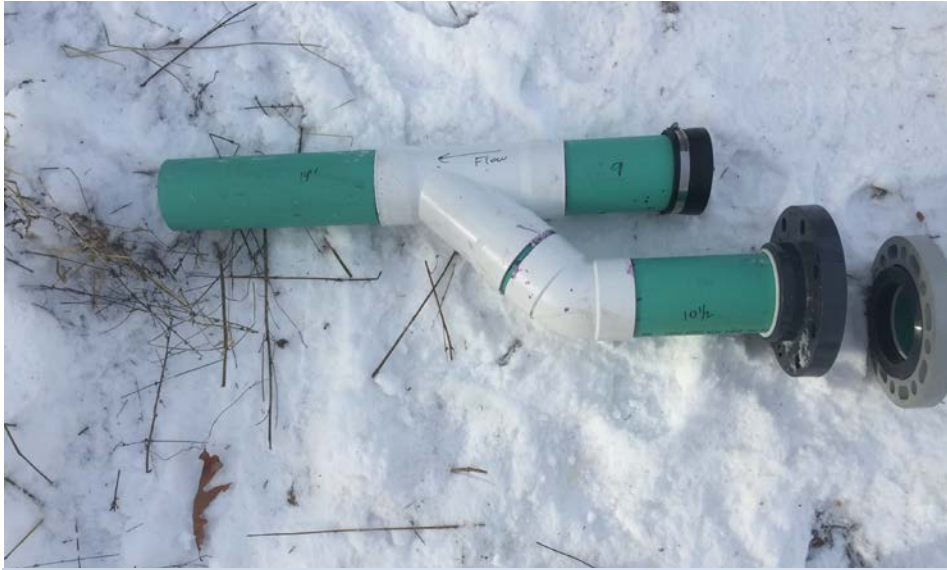
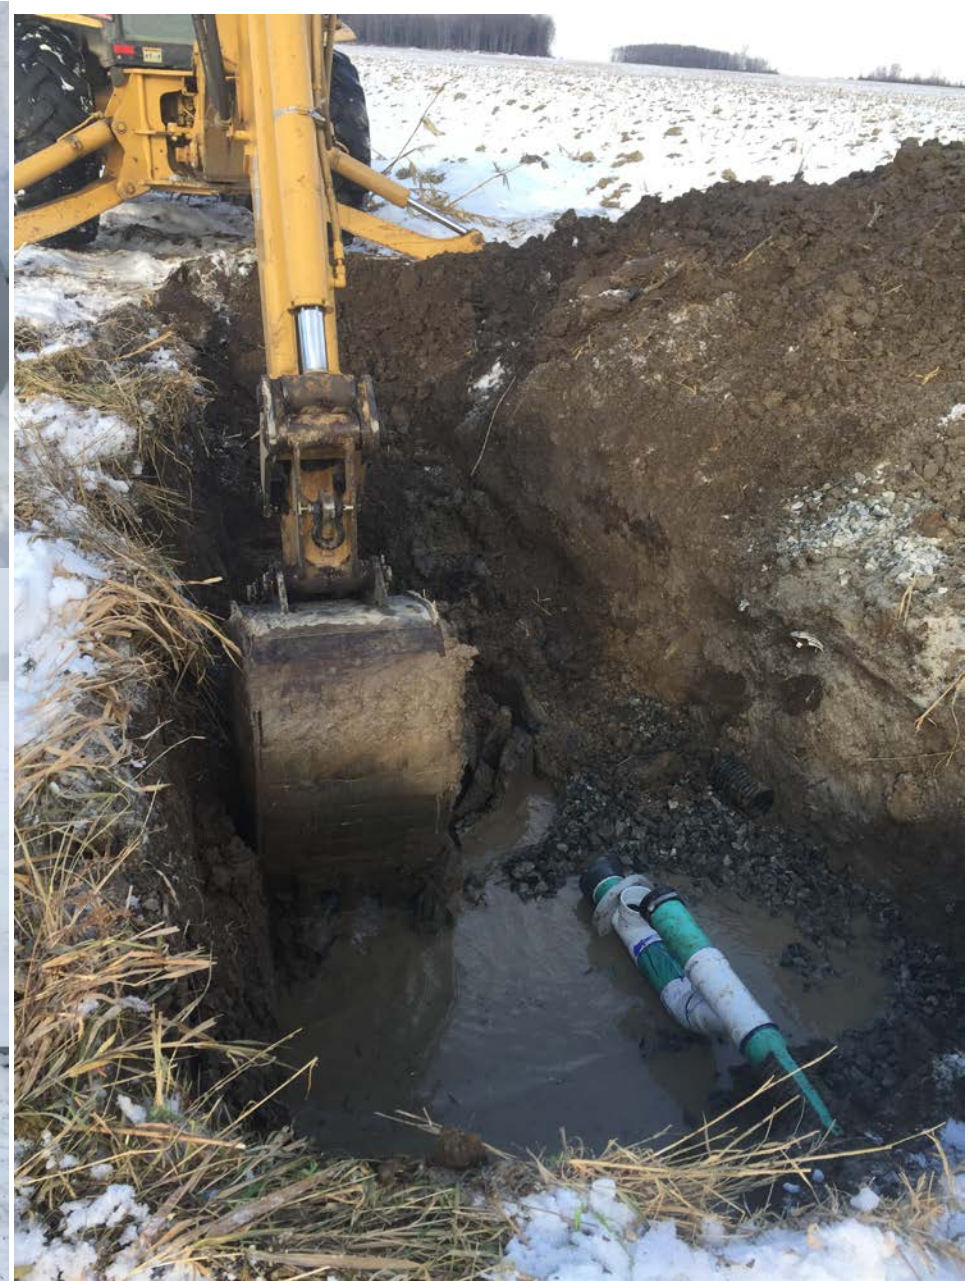
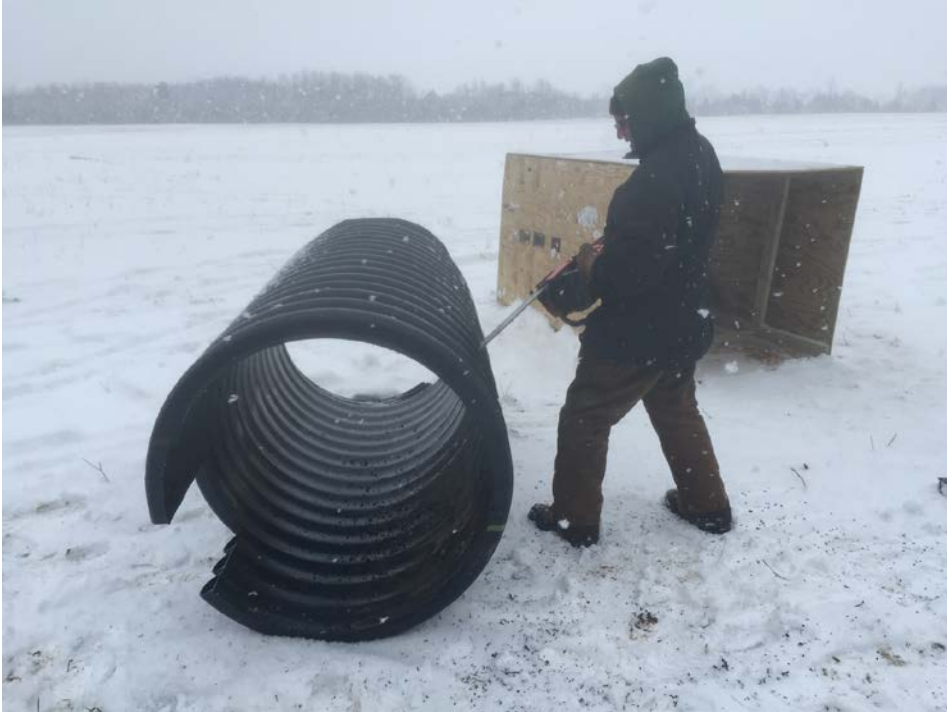
# Monitoring Manhole Construction

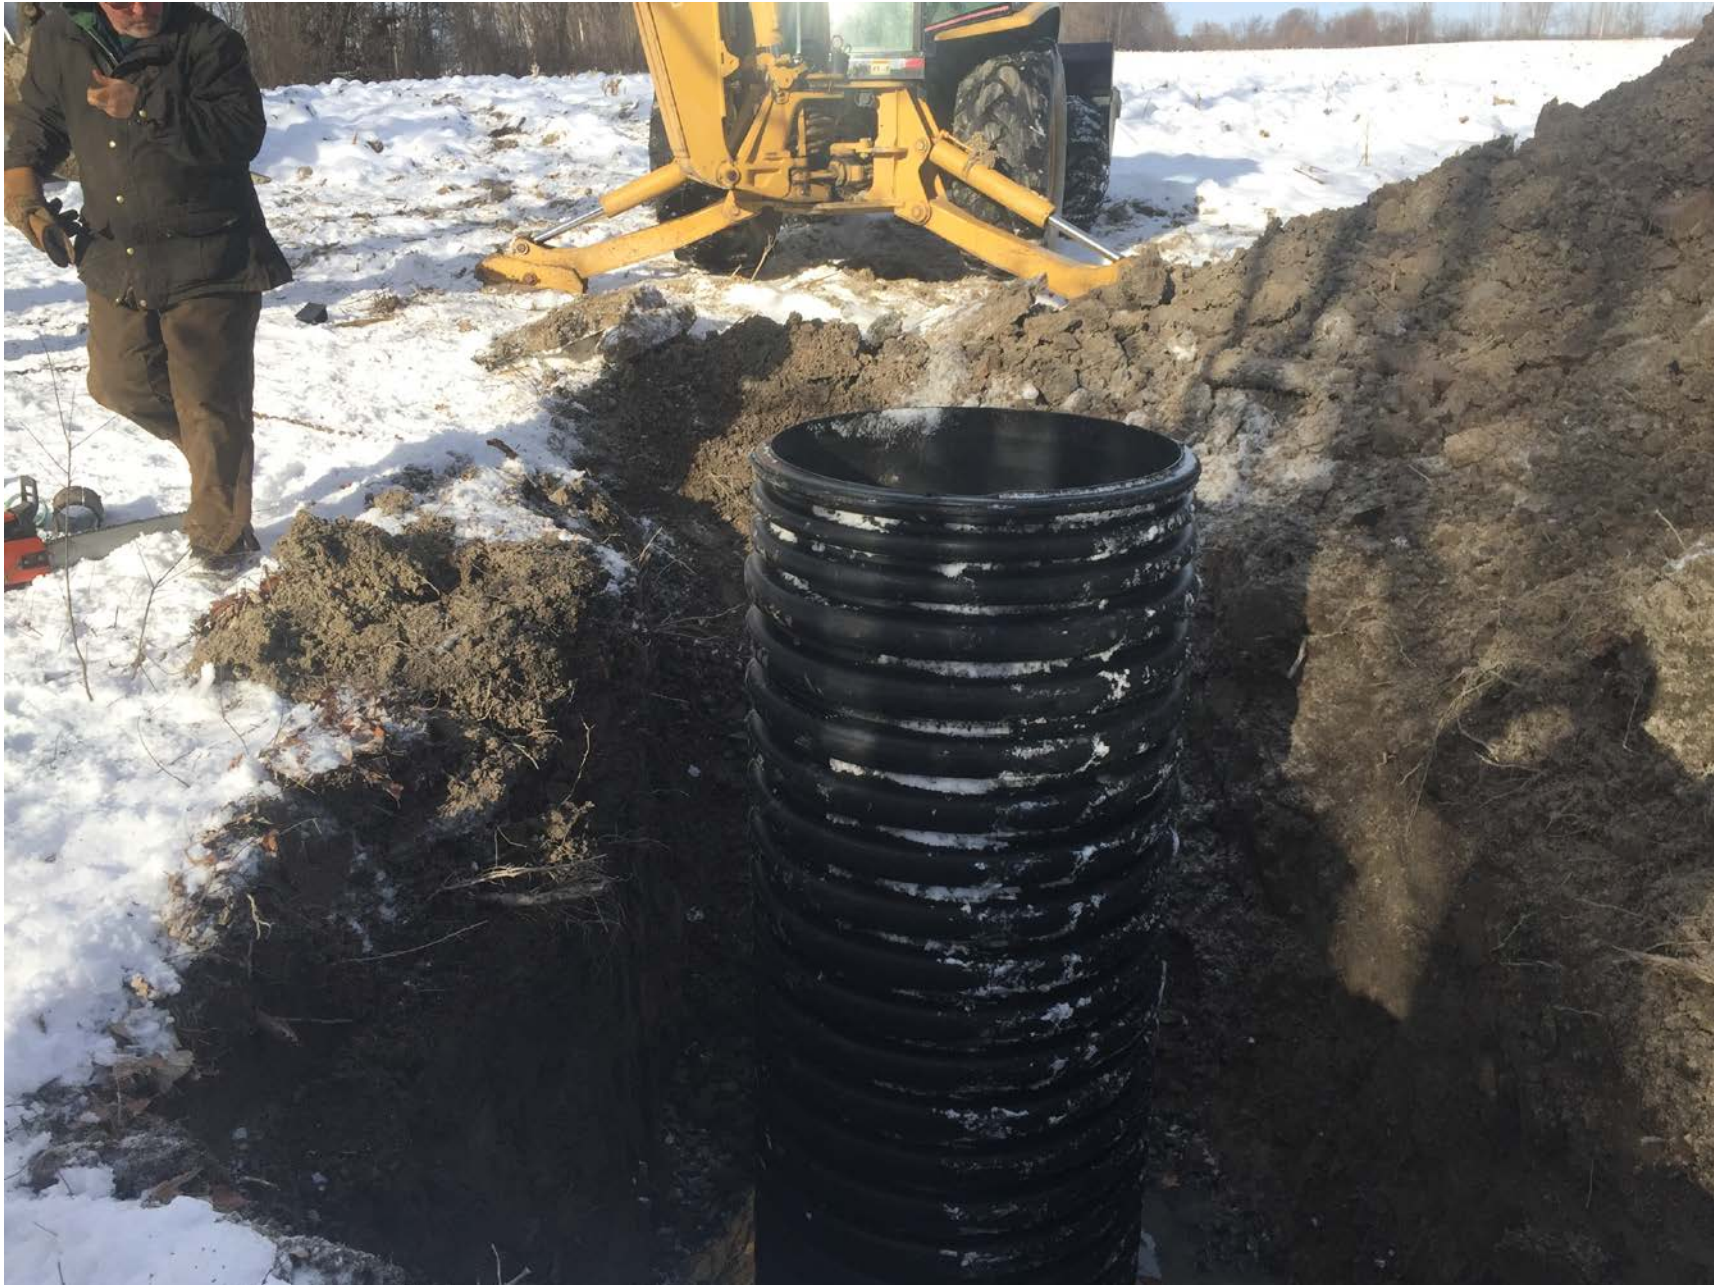
# Monitoring Manhole Construction

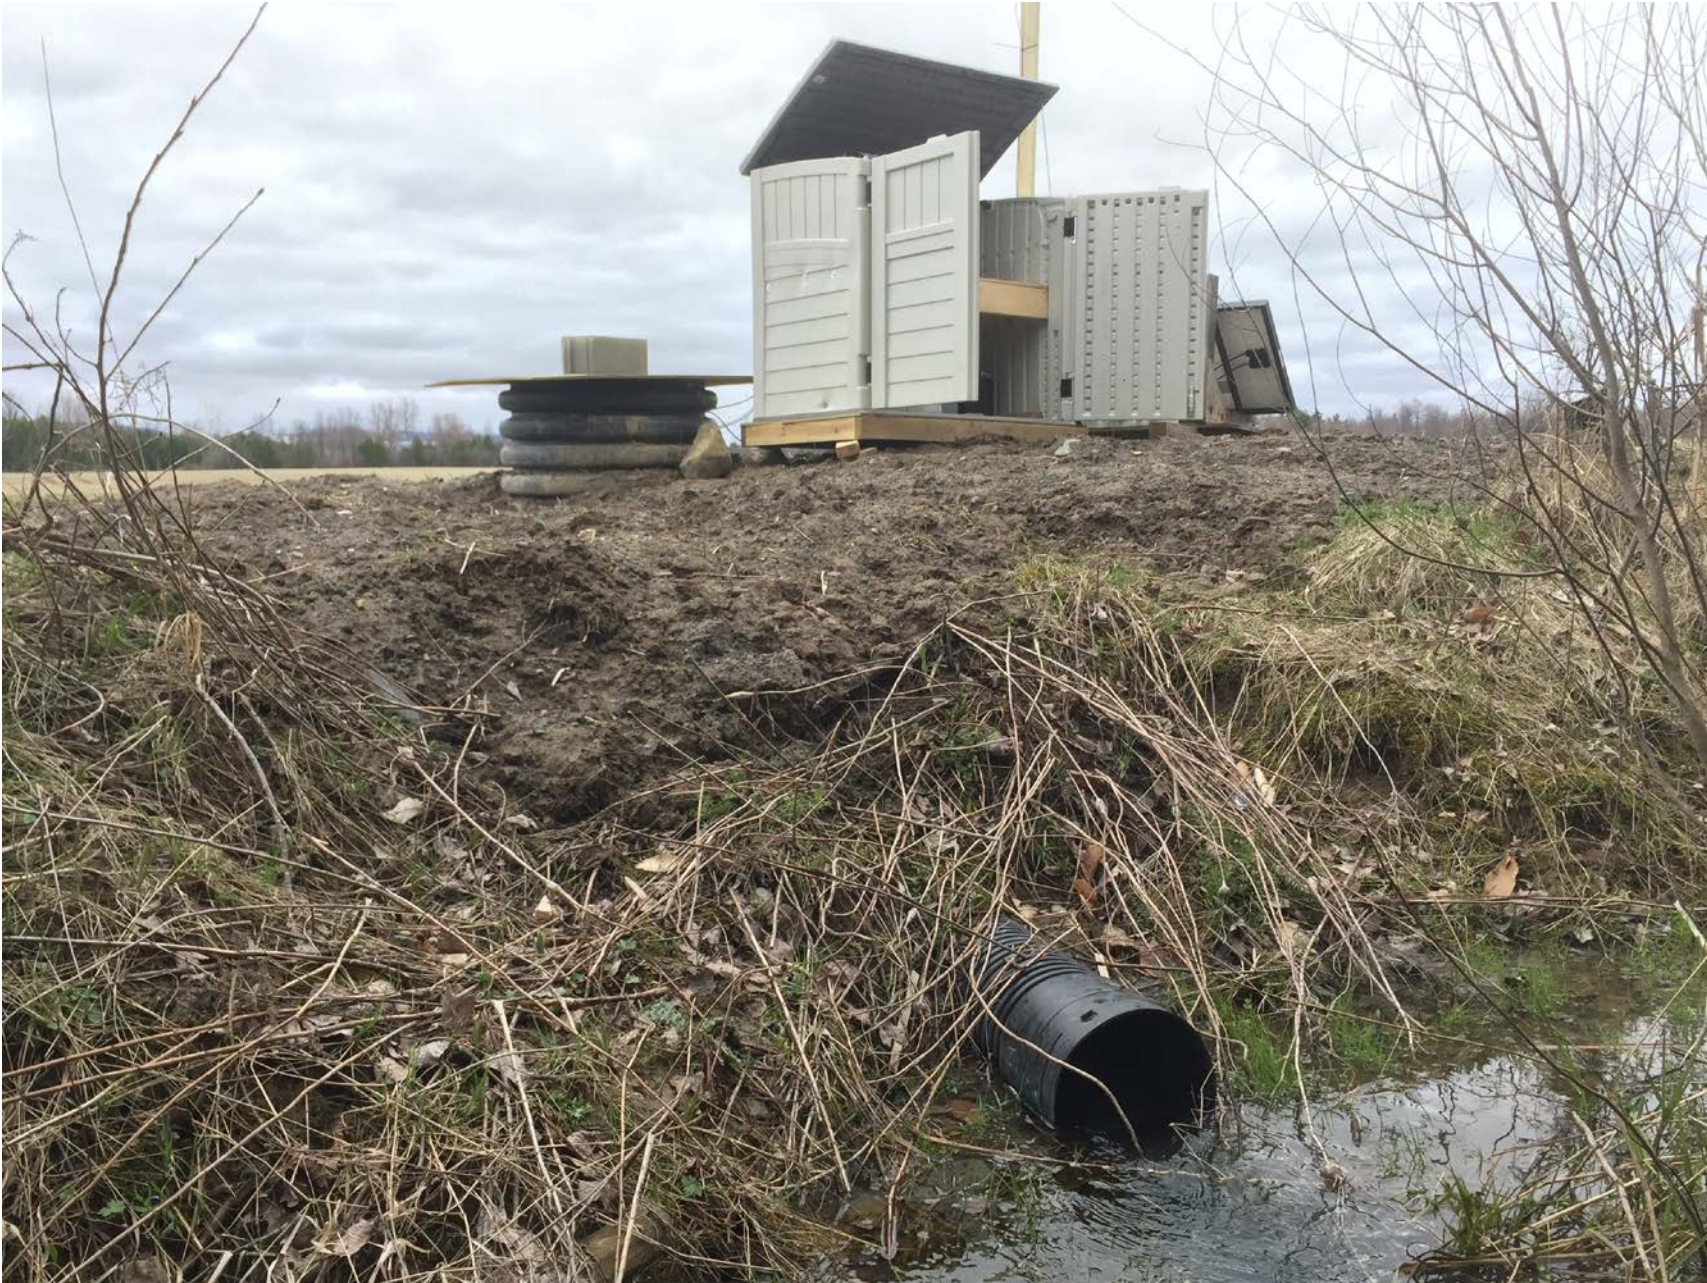
# JBT11 Monitoring Station

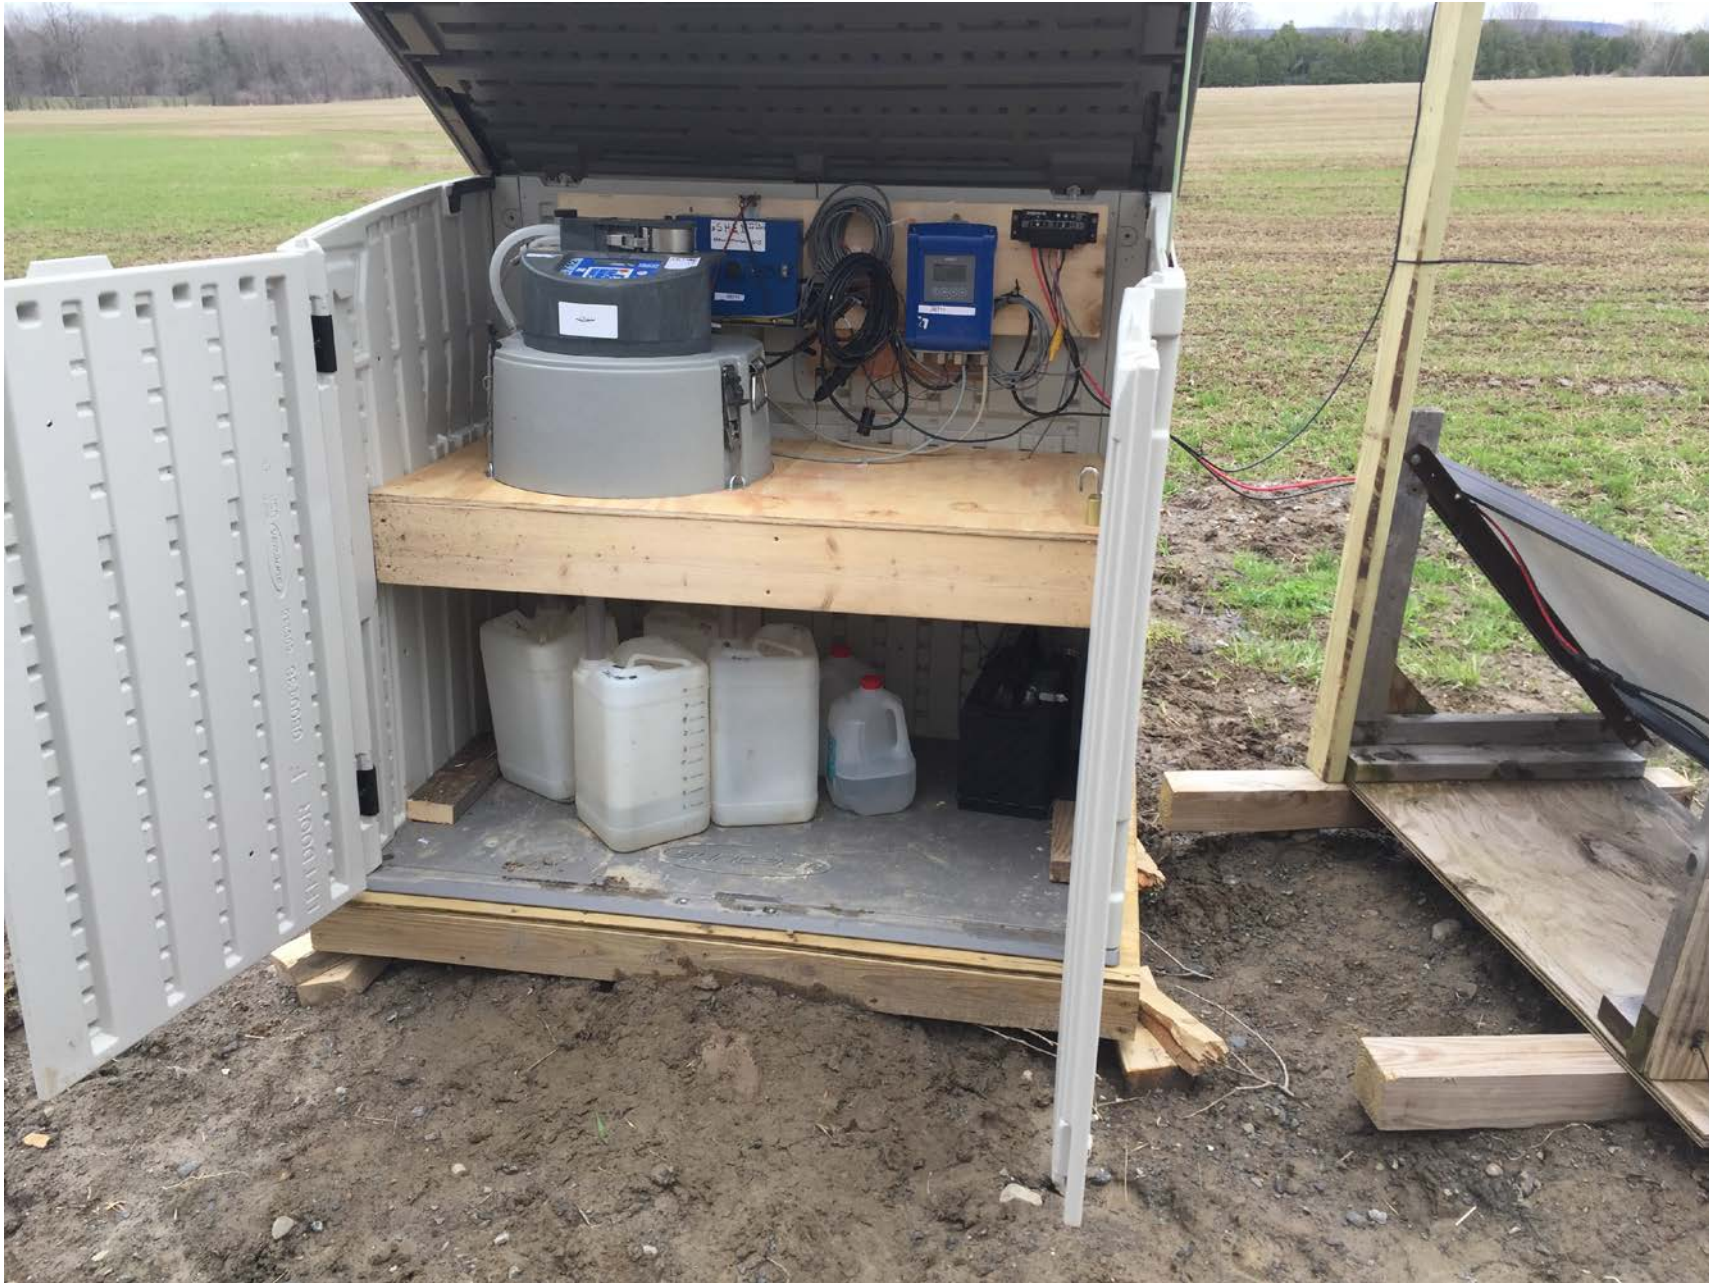
# Typical Instrument Shelter (JBT11)

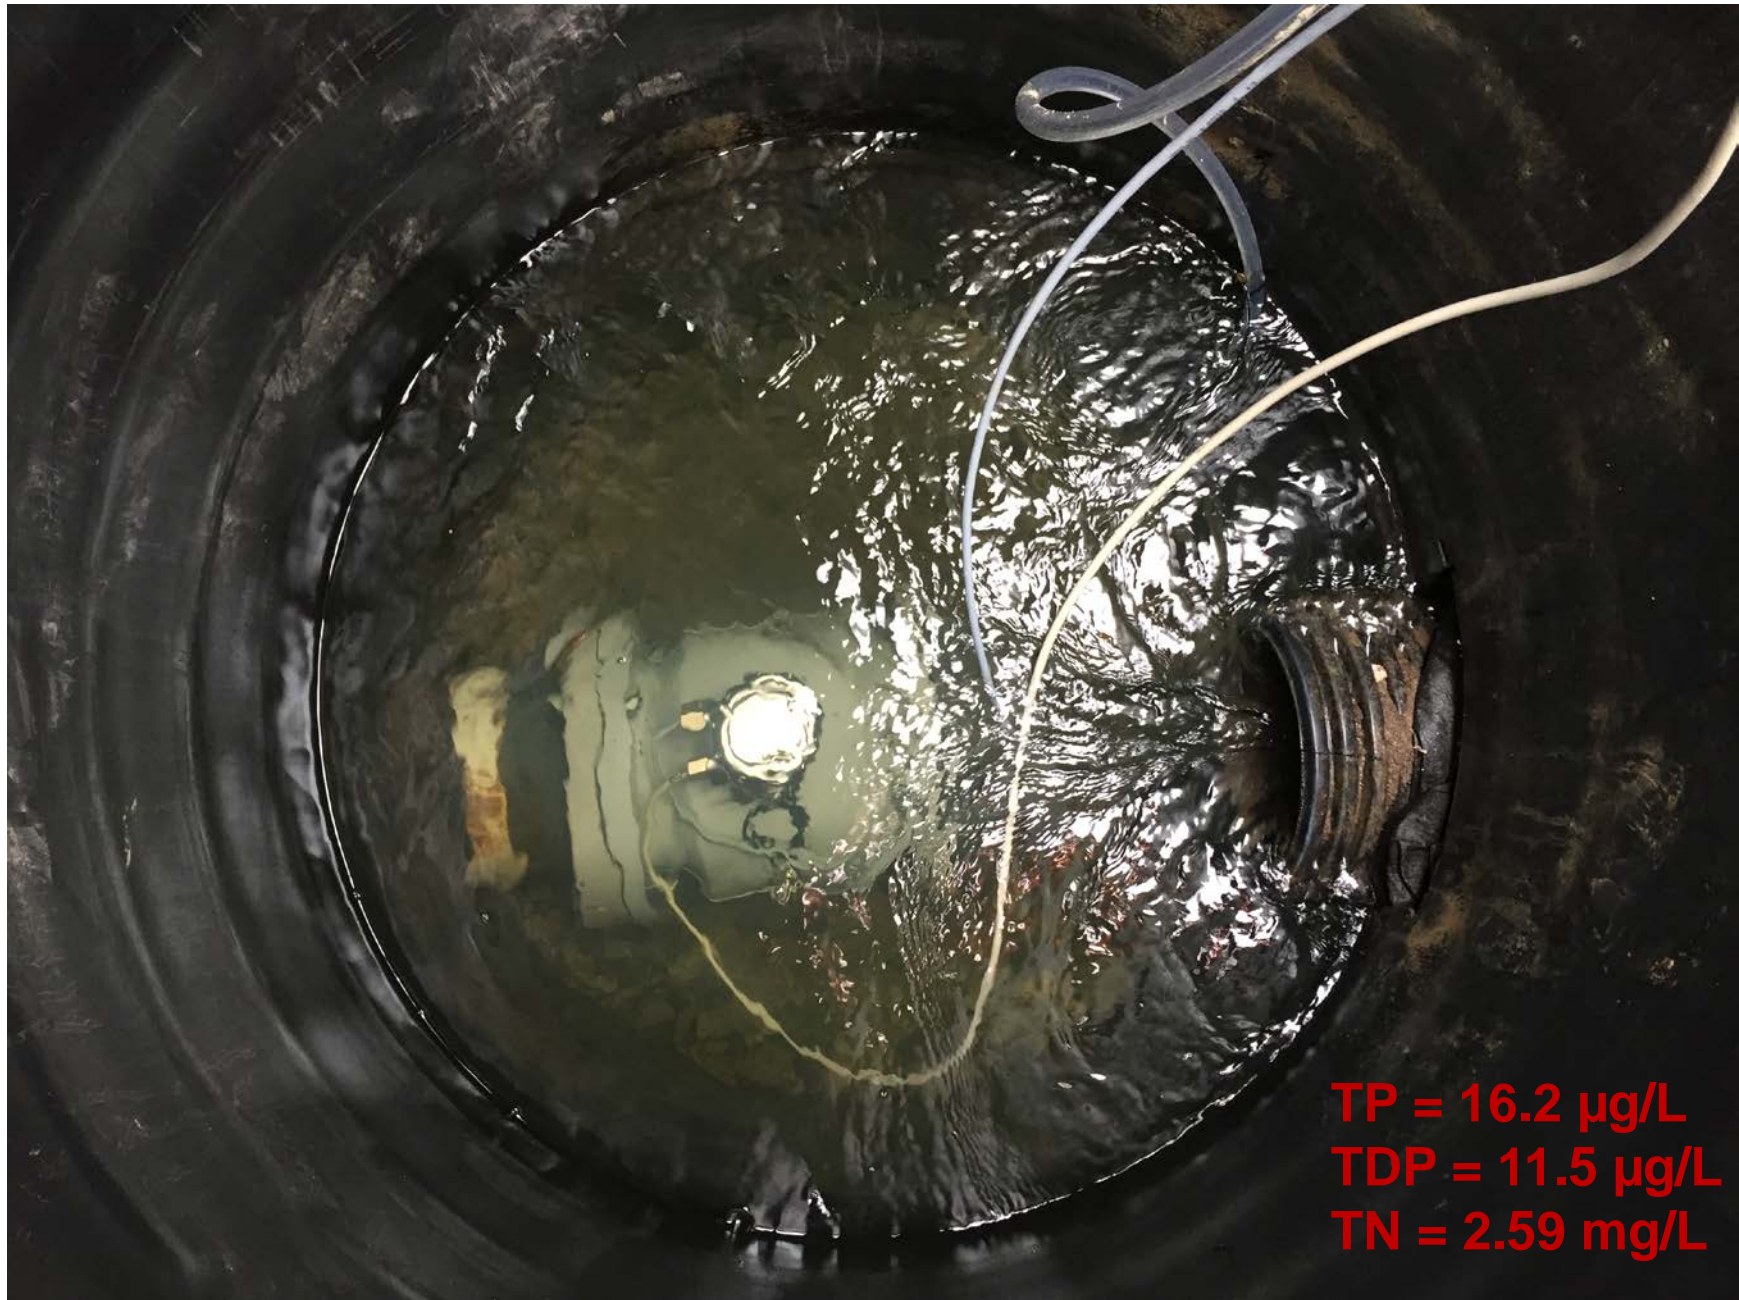
# Waterflux 3000 Flowmeter at JBT11, April 20, 2017

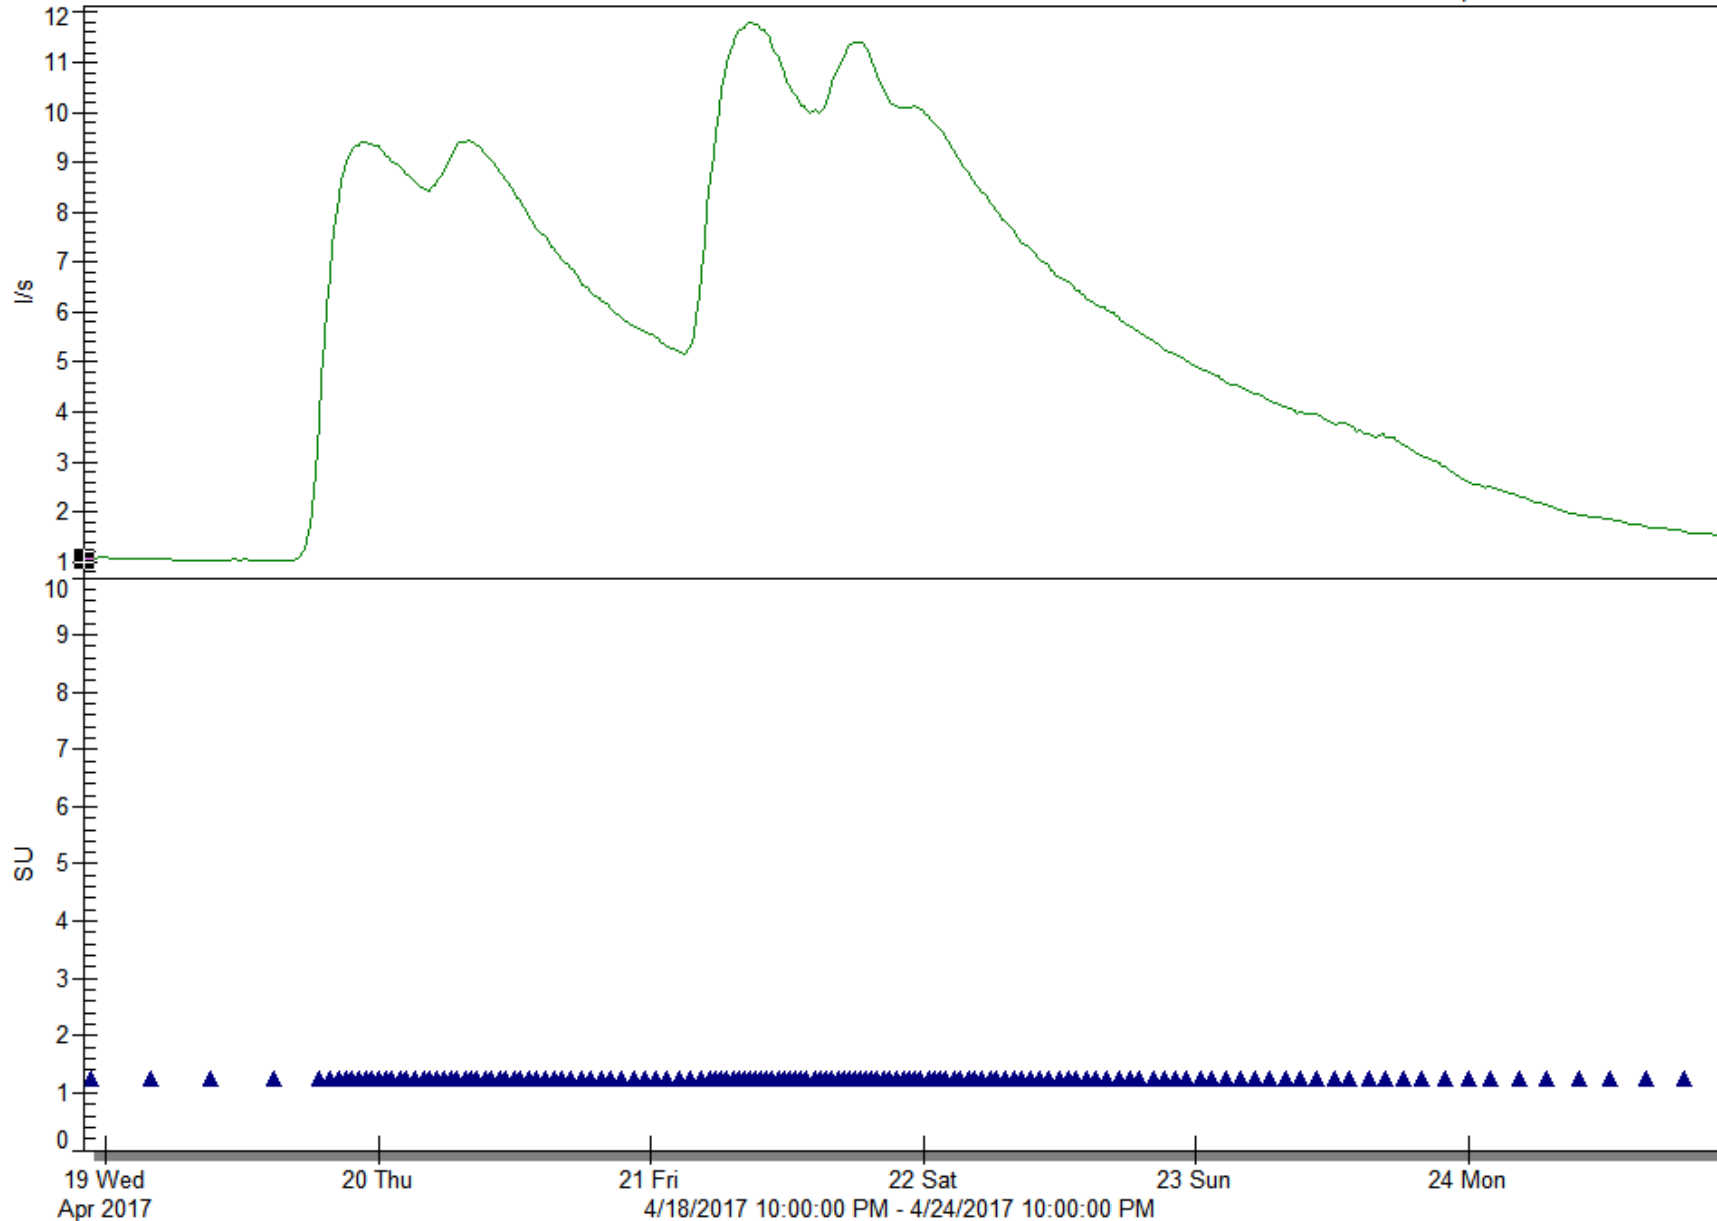
# Flow Proportional Sampling at JBT06

JBT06.2110 US.Flow Rate

JBT06.2105 Interface Module.Sampler

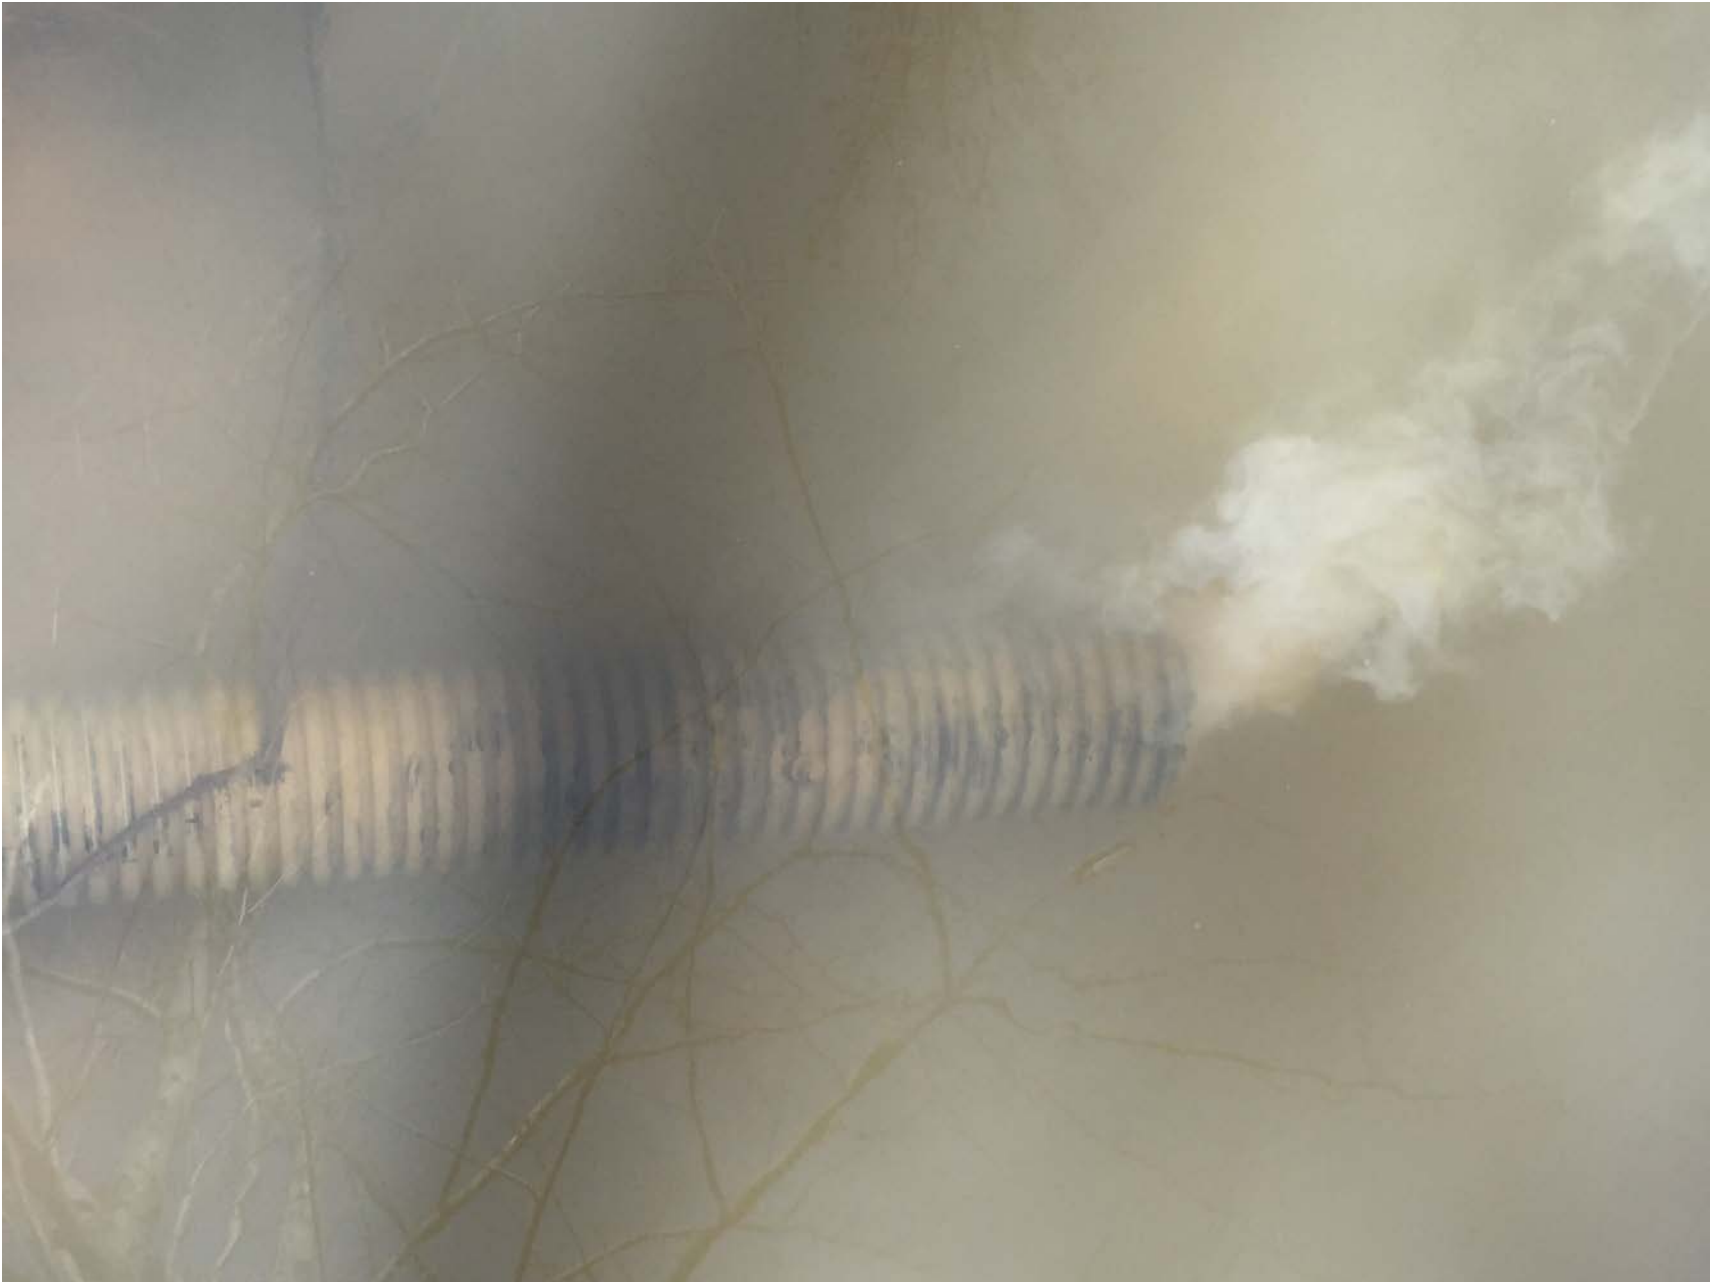
# Tile drain muddying already turbid Jewett Brook

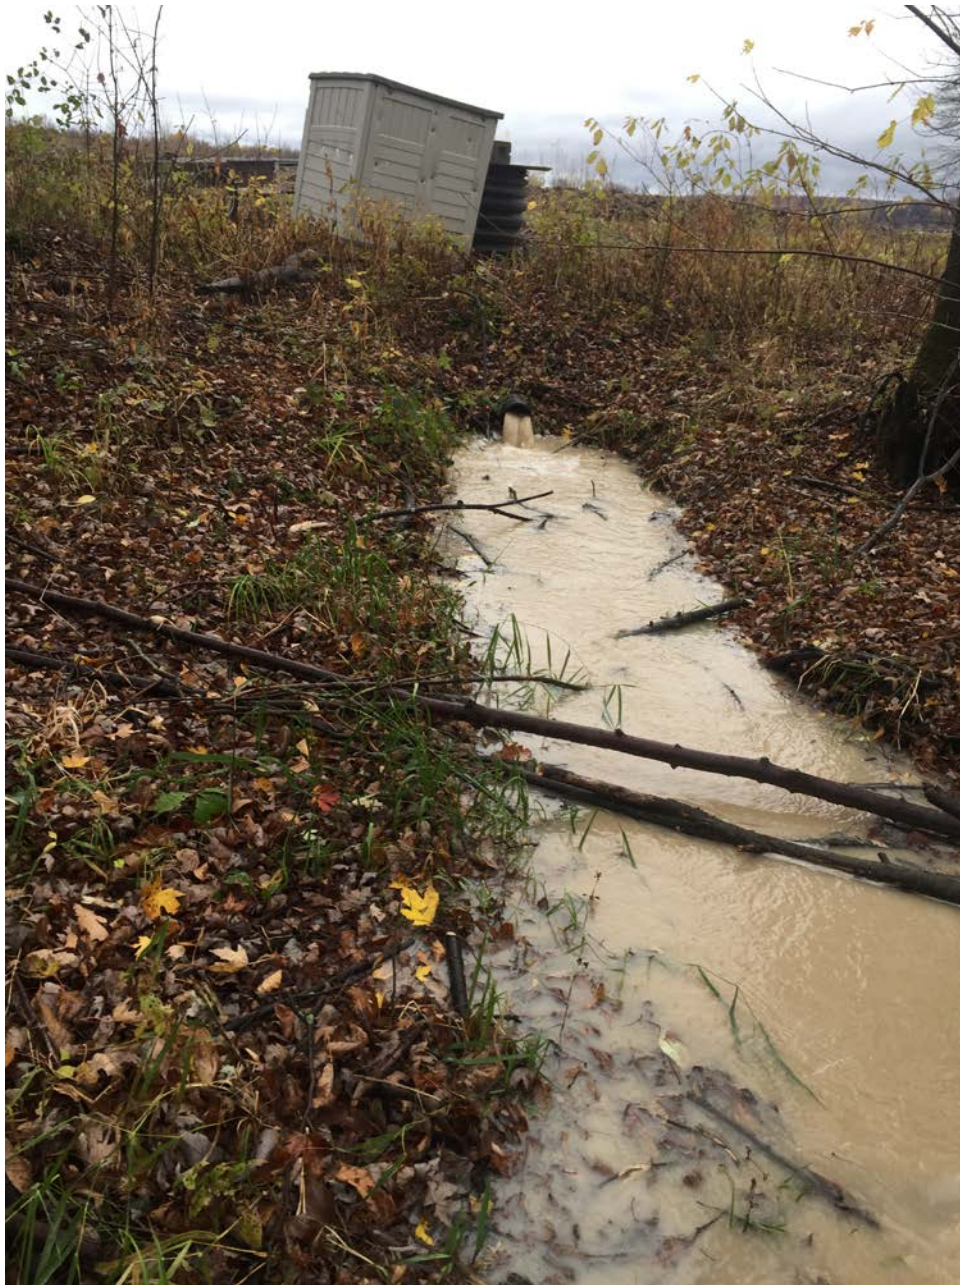
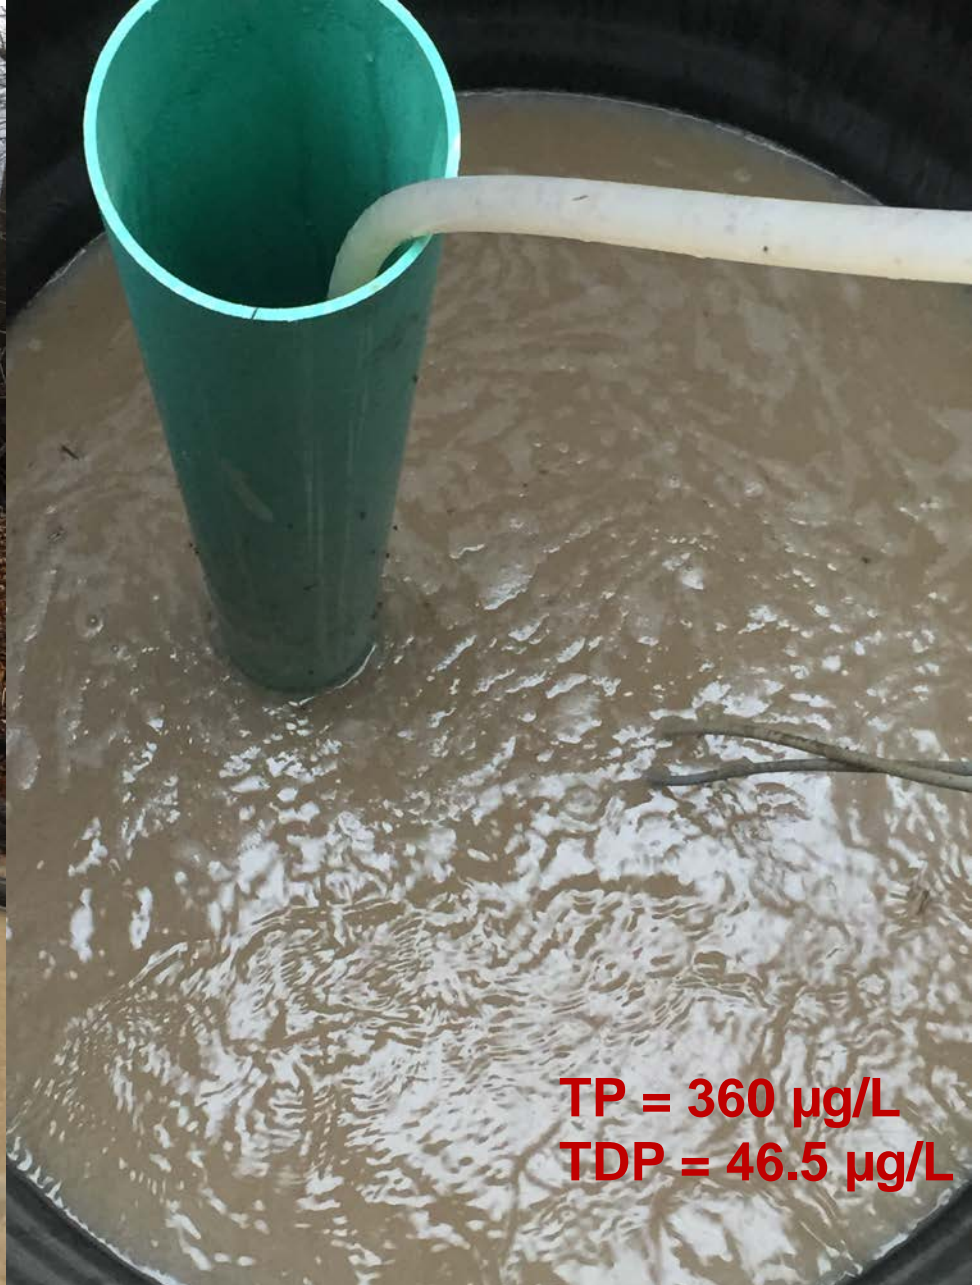
# JBT01 flowing muddy, November 3, 2017
