# **Assessment of Tile Drainage System Impacts to Lake Champlain and Phosphorus Loads in Tile Drainage in the Jewett Brook Watershed of St. Albans Bay**

Date: December 21, 2017

Conference/Venue: Tile Drain Advisory Group Meeting

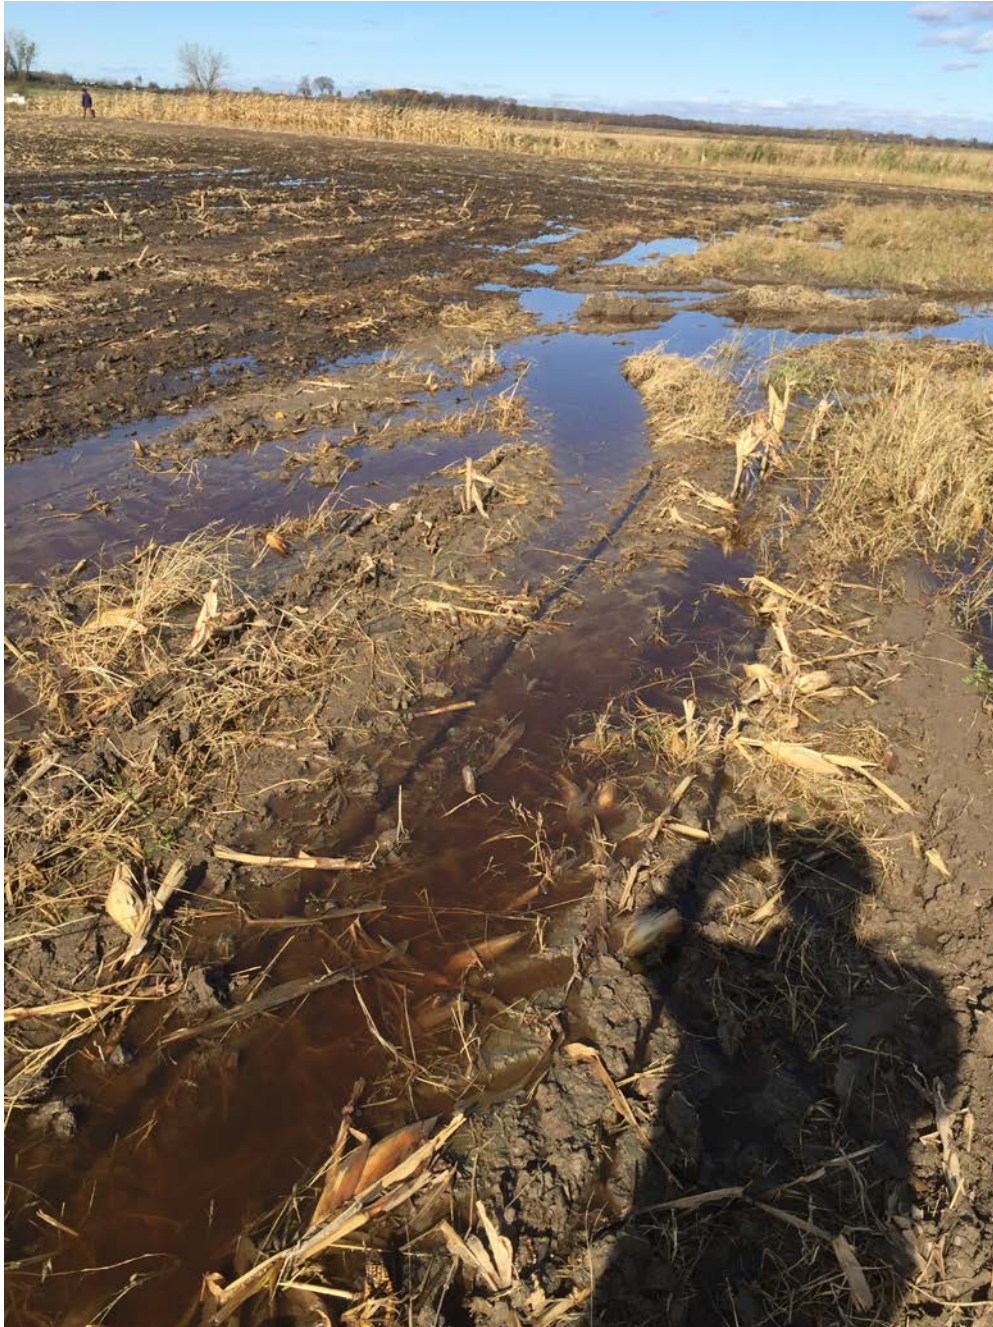
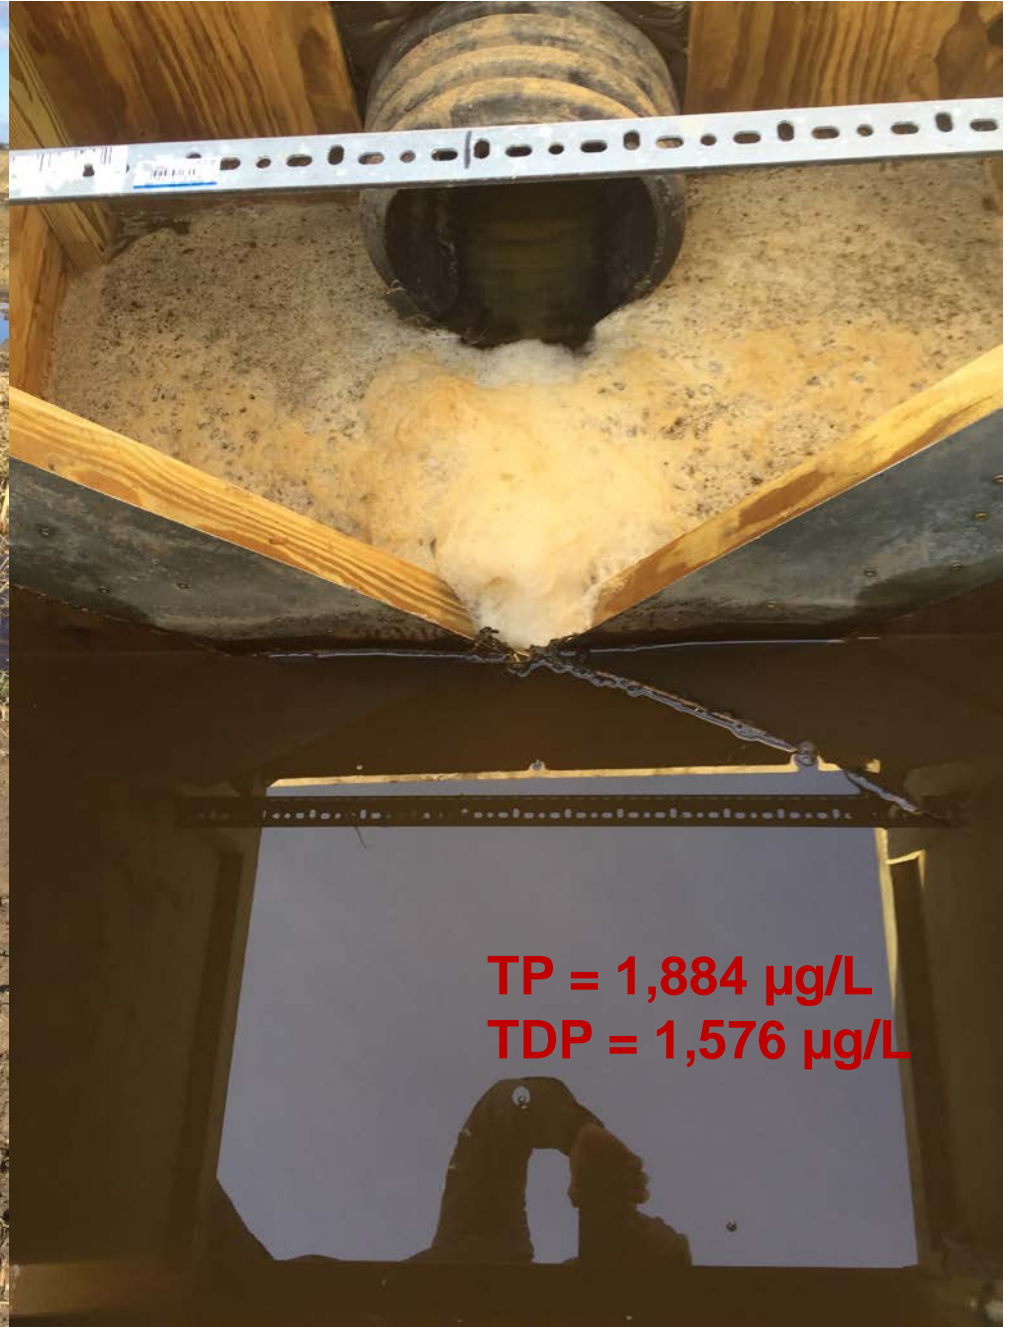
# JBT06 field on October 27, 2017 after manure injection

TP = 1,884  $\mu\text{g/L}$   
TDP = 1,576  $\mu\text{g/L}$

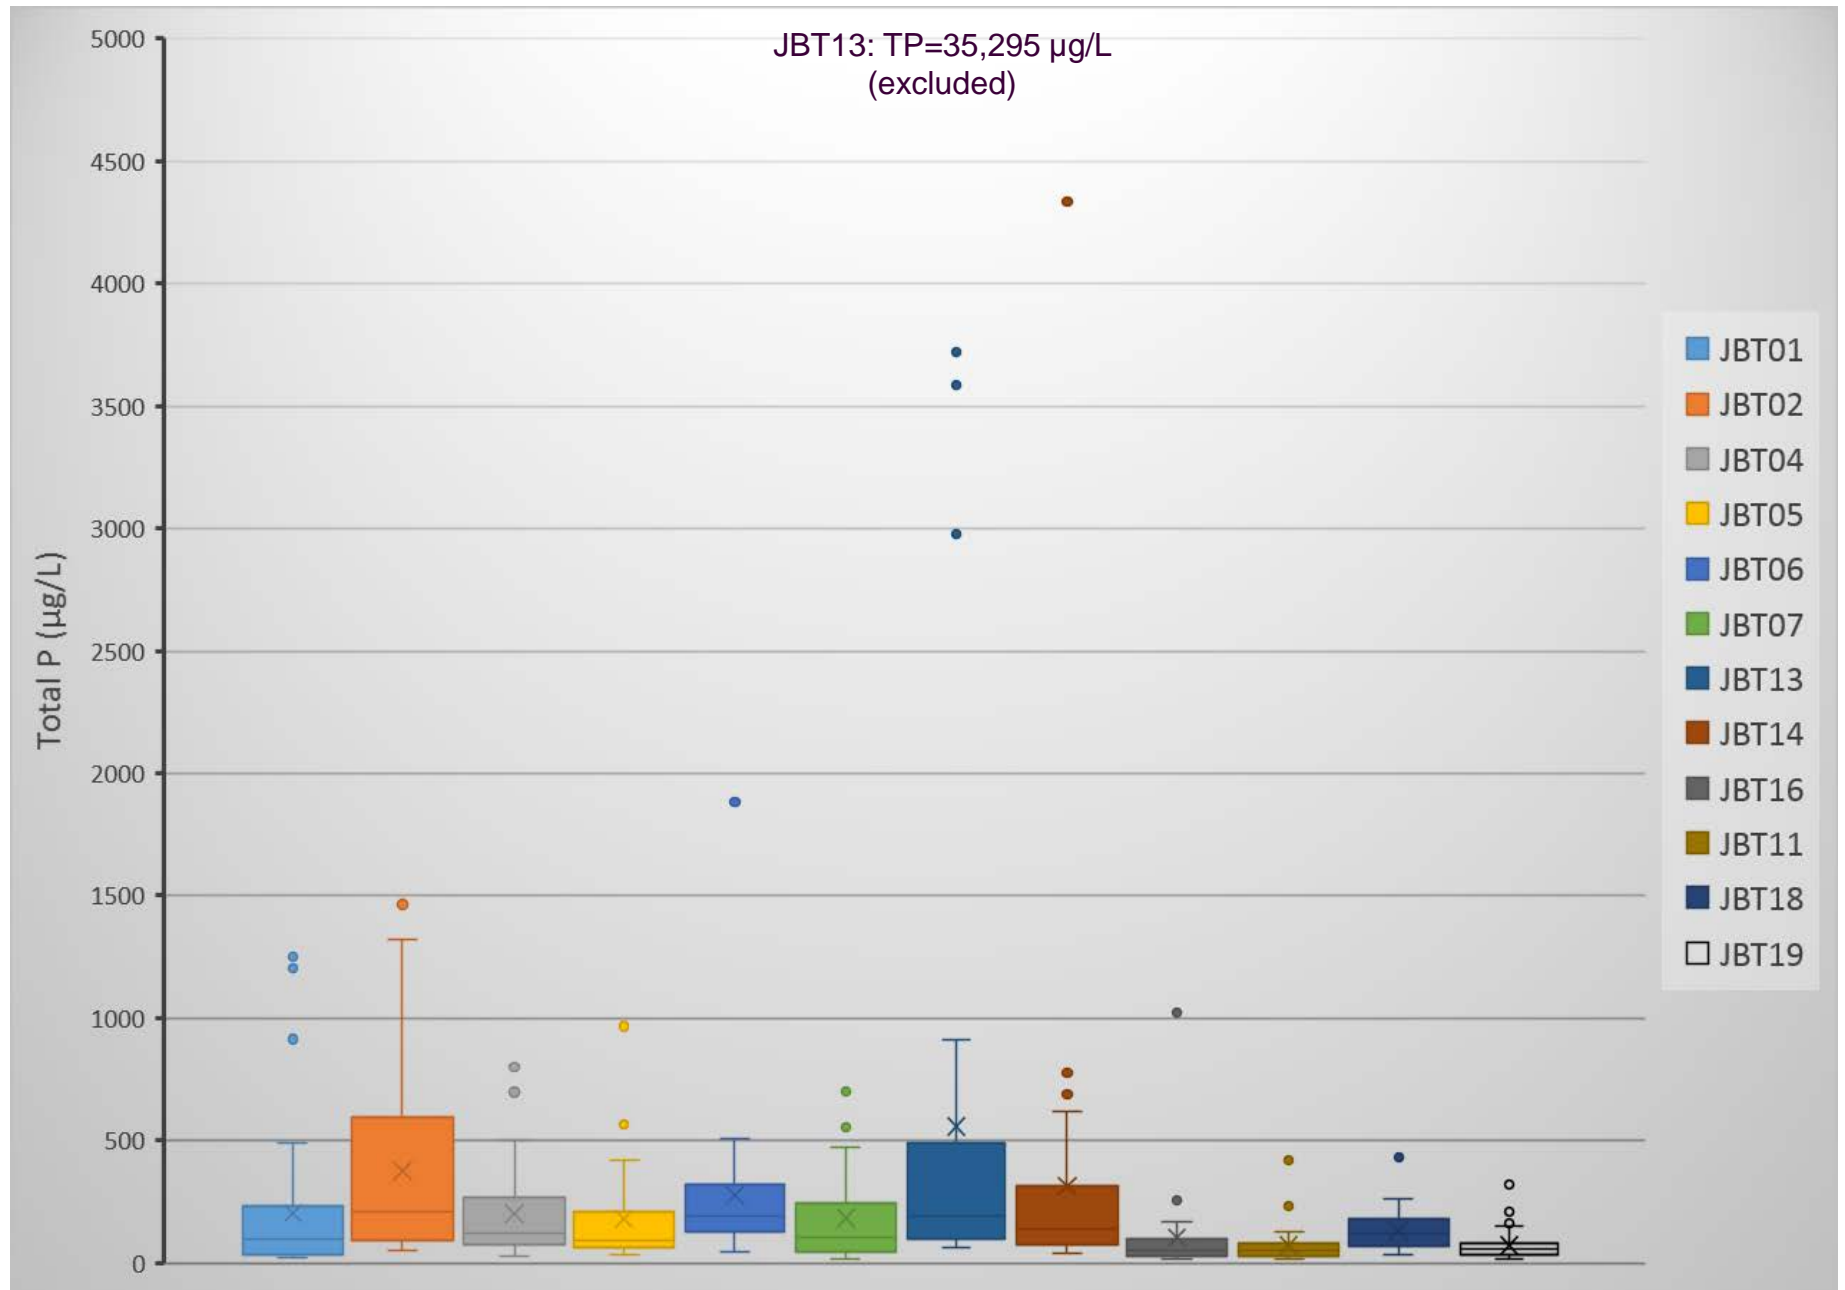
# Distributions of Total P EMCs (April – Nov., 2017)

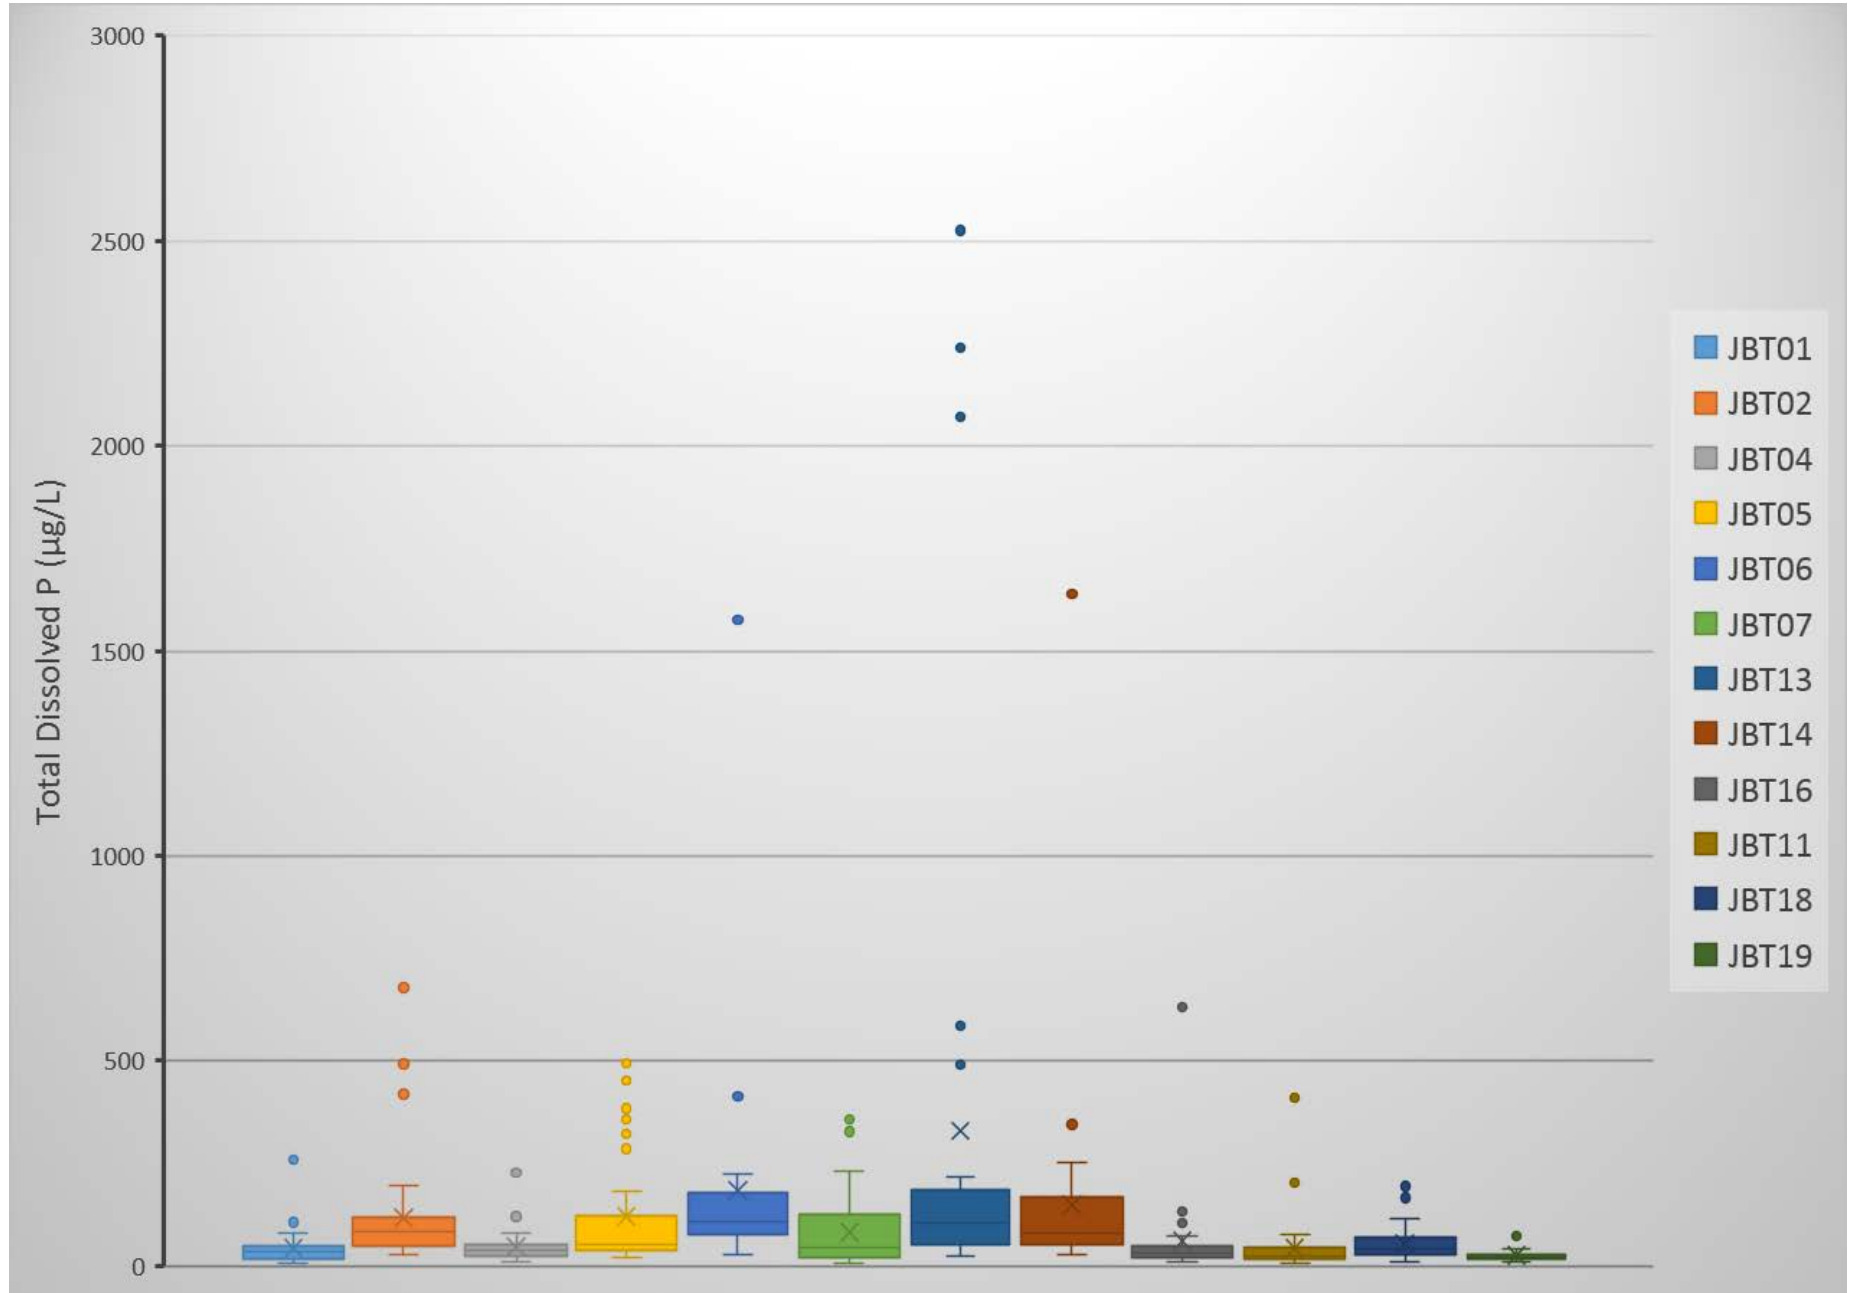
# Distributions of Total Dissolved P EMCs (April – Nov., 2017)

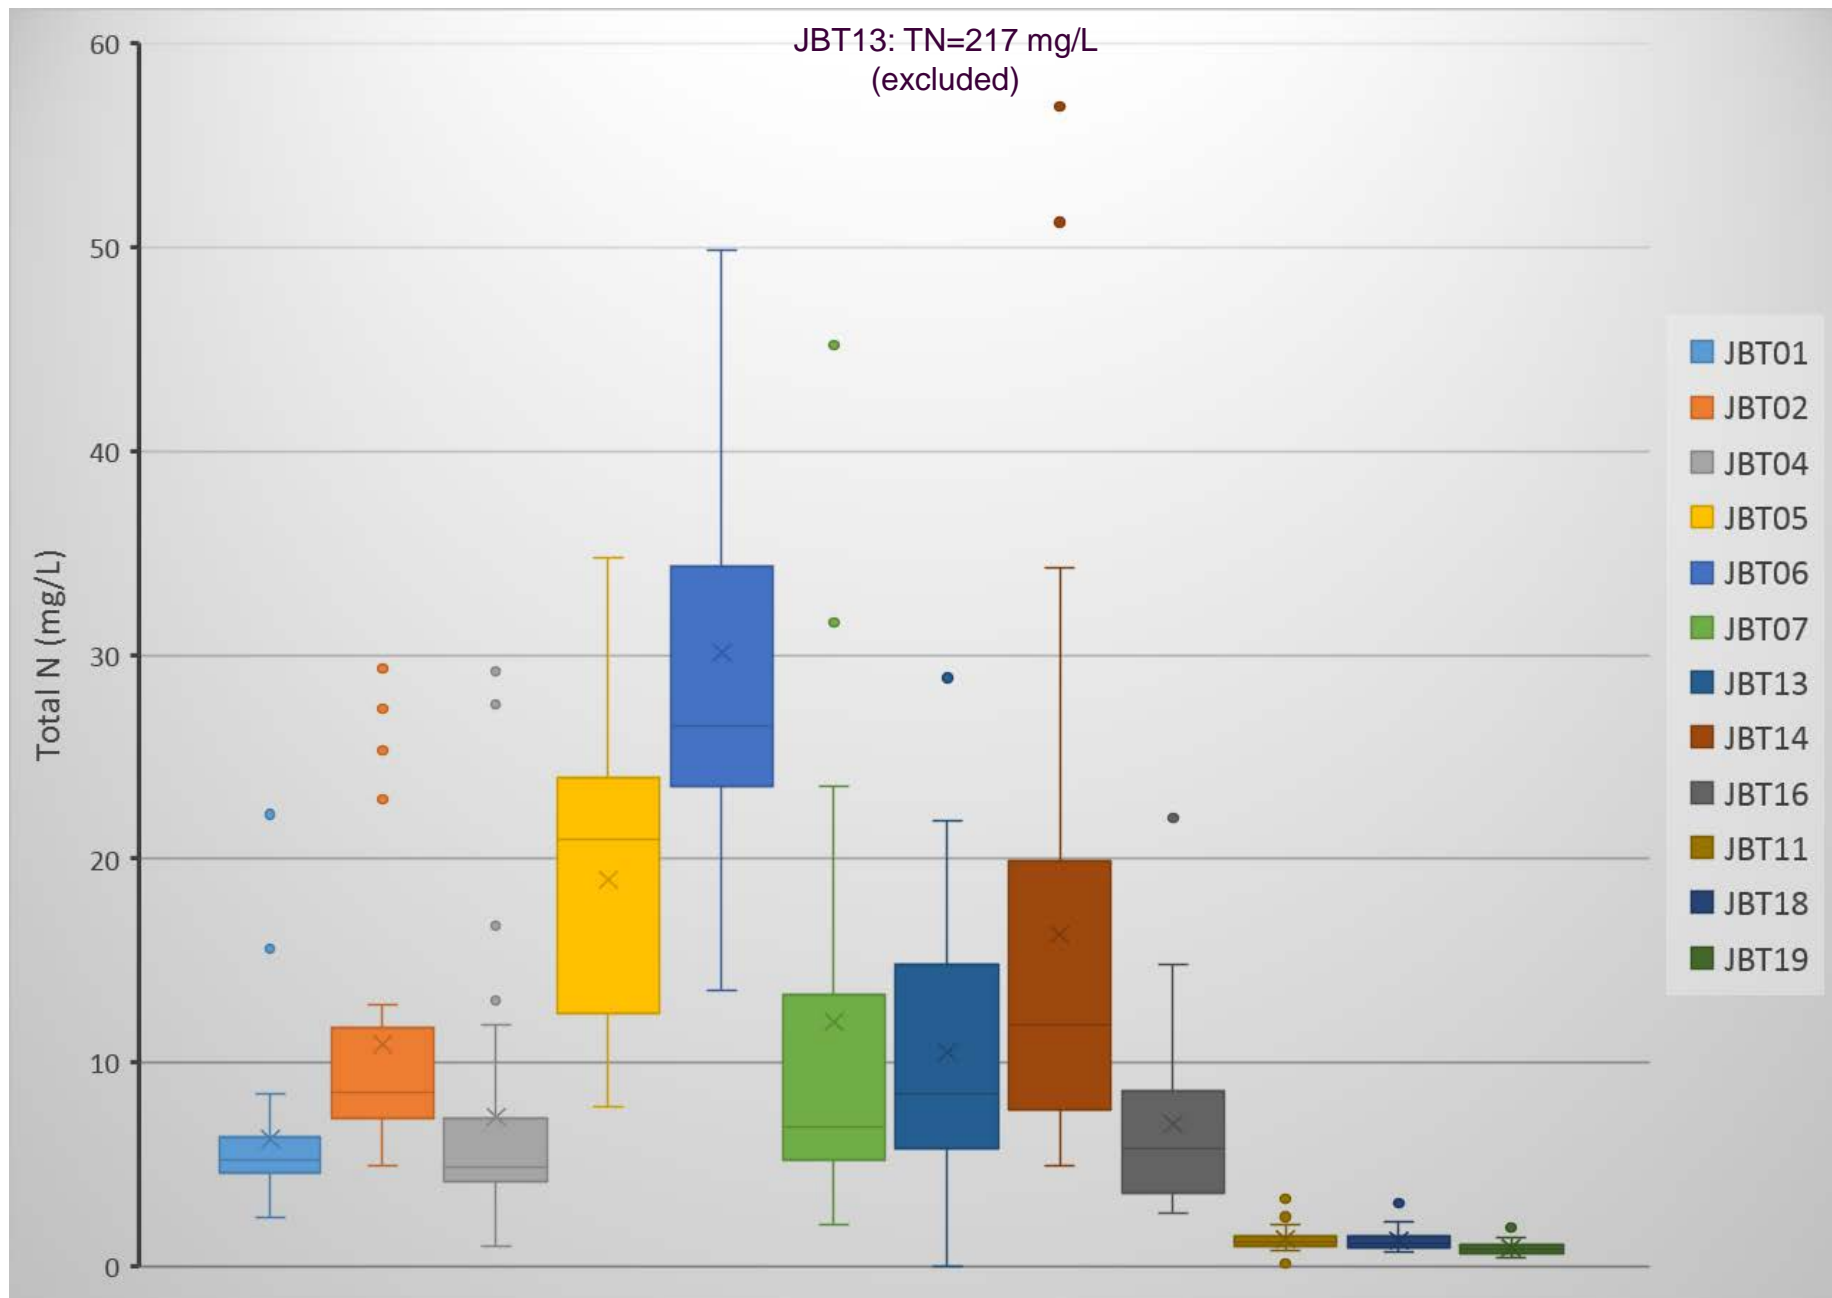
# Distributions of Total N EMCs (April – Nov., 2017)

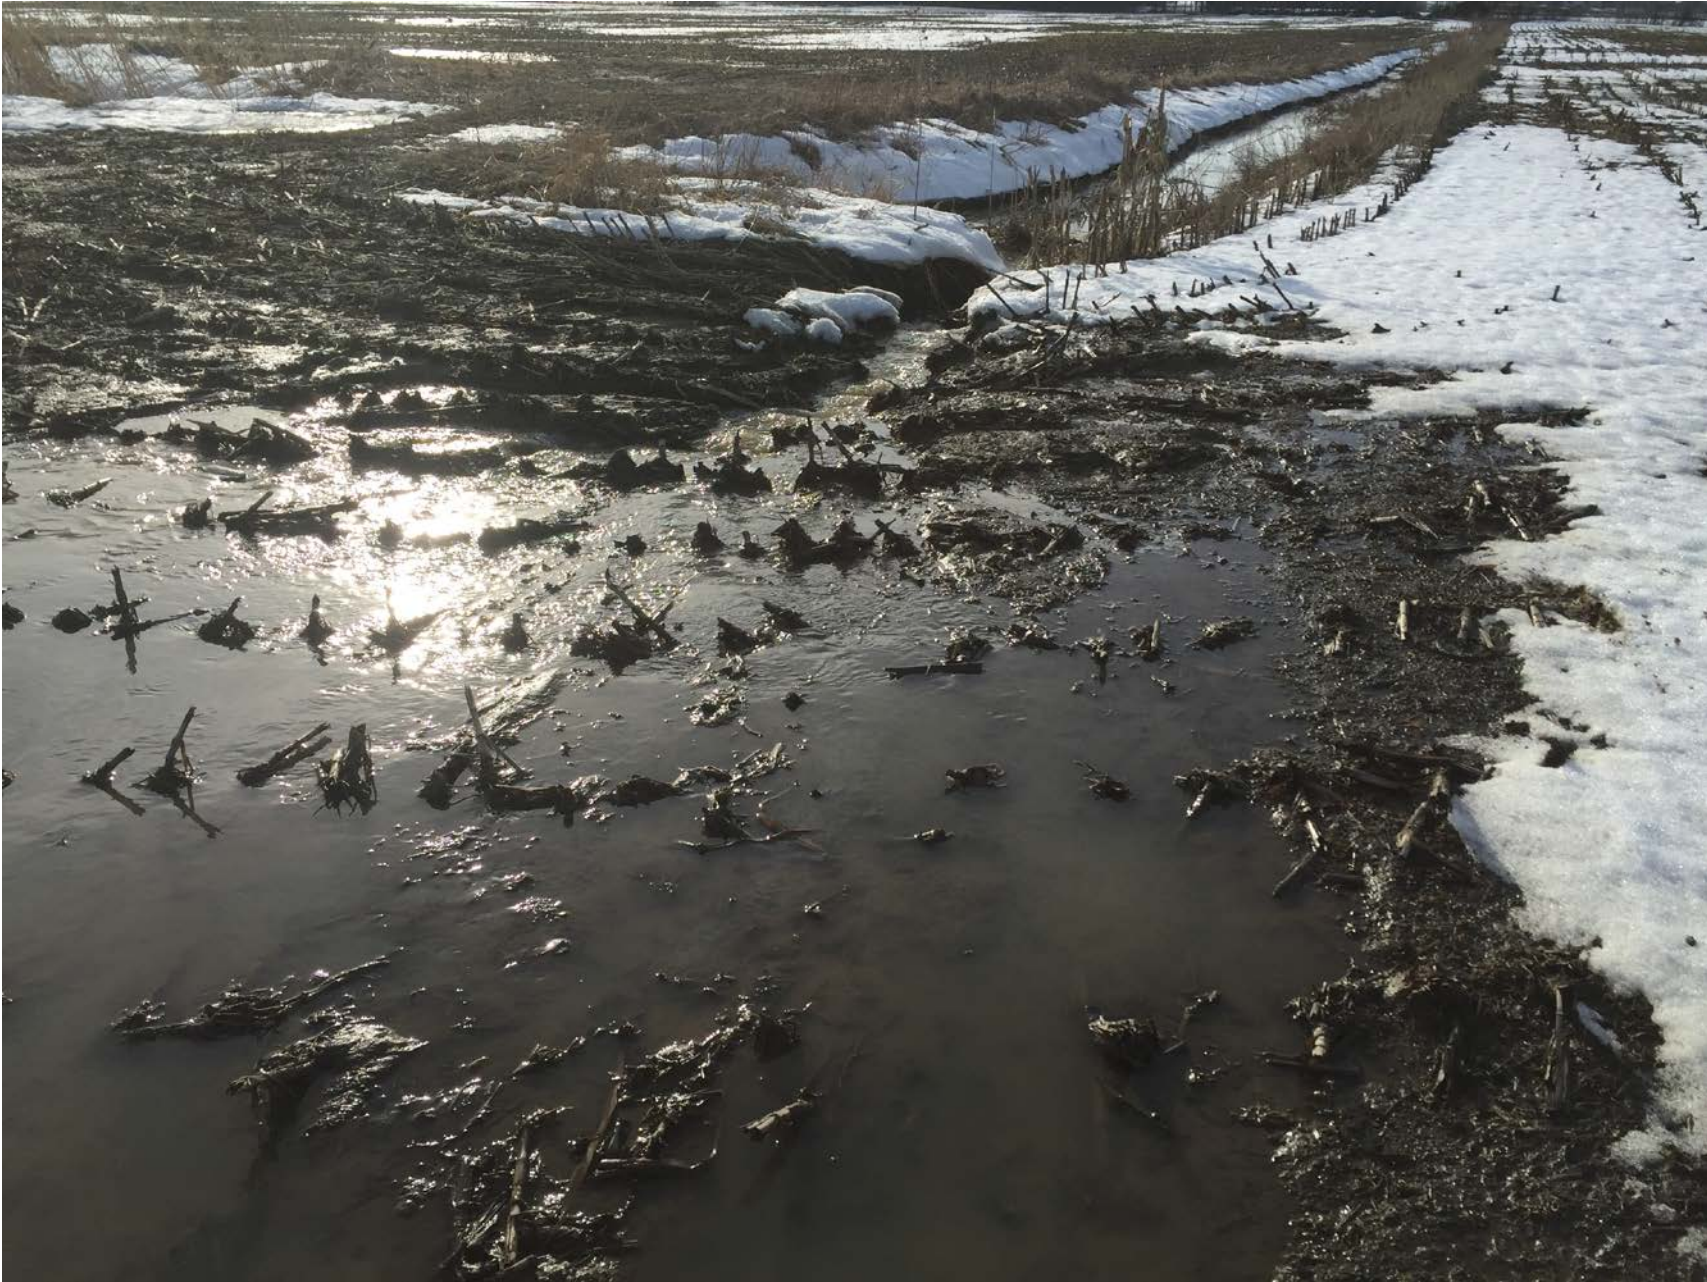
# Runoff and Erosion on Tiled Field (JBT14)

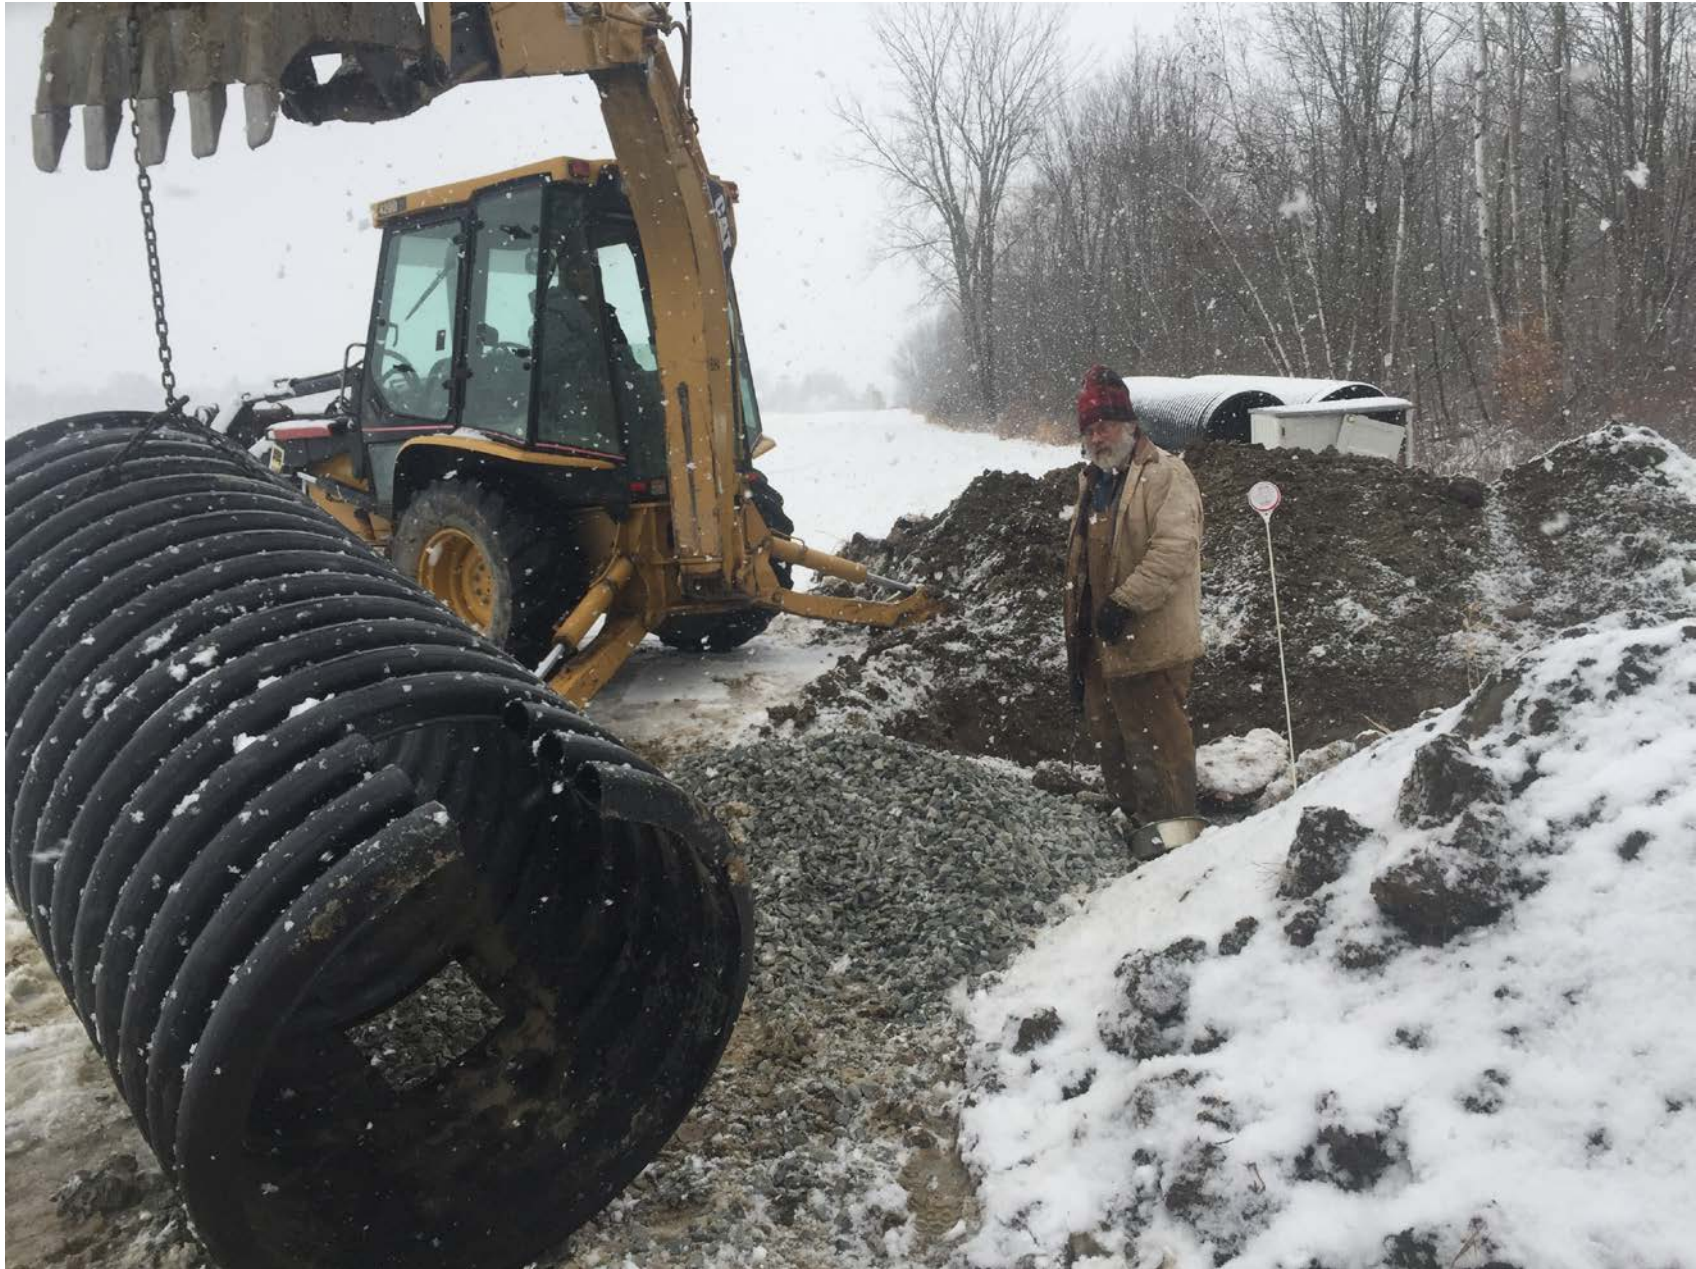
# Monitoring Manhole Construction

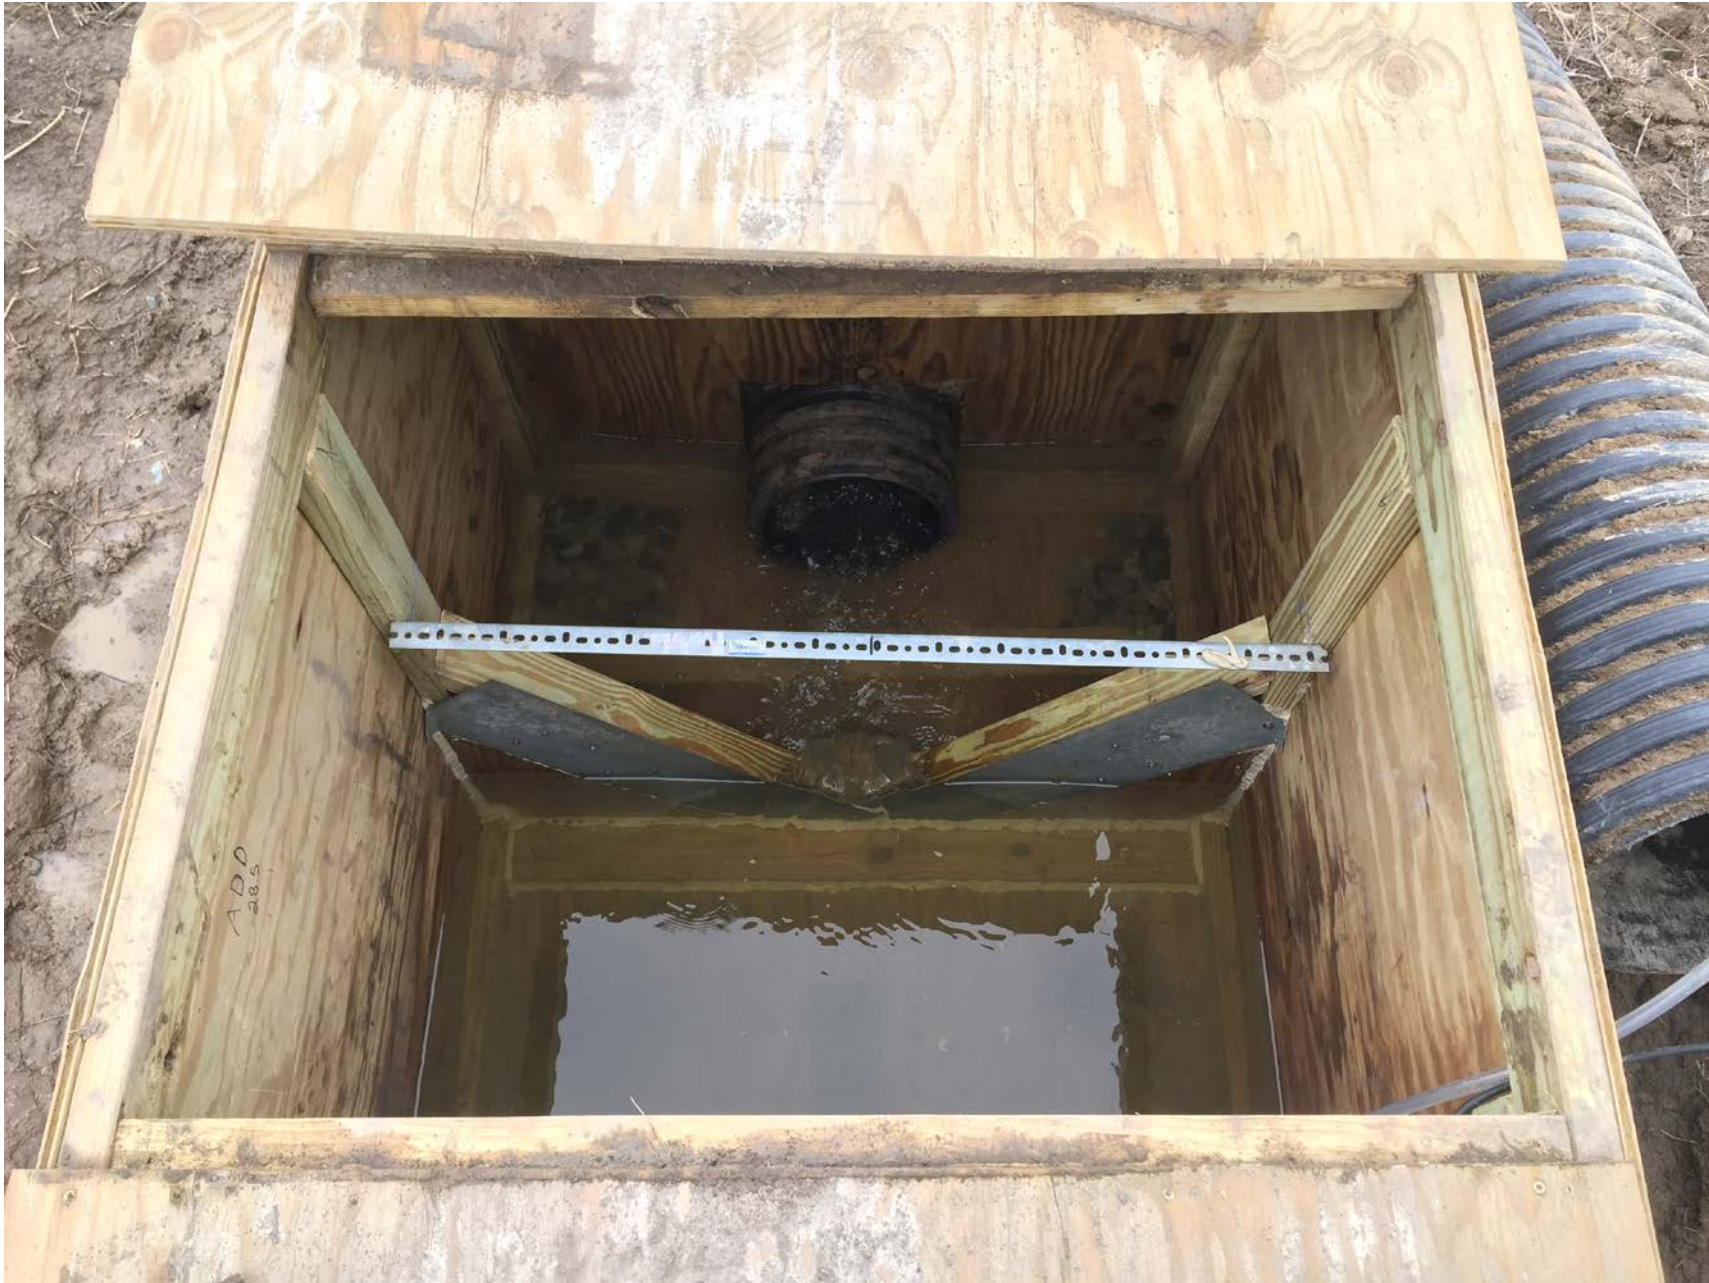
# Weir Box Constructed at Station JBT06

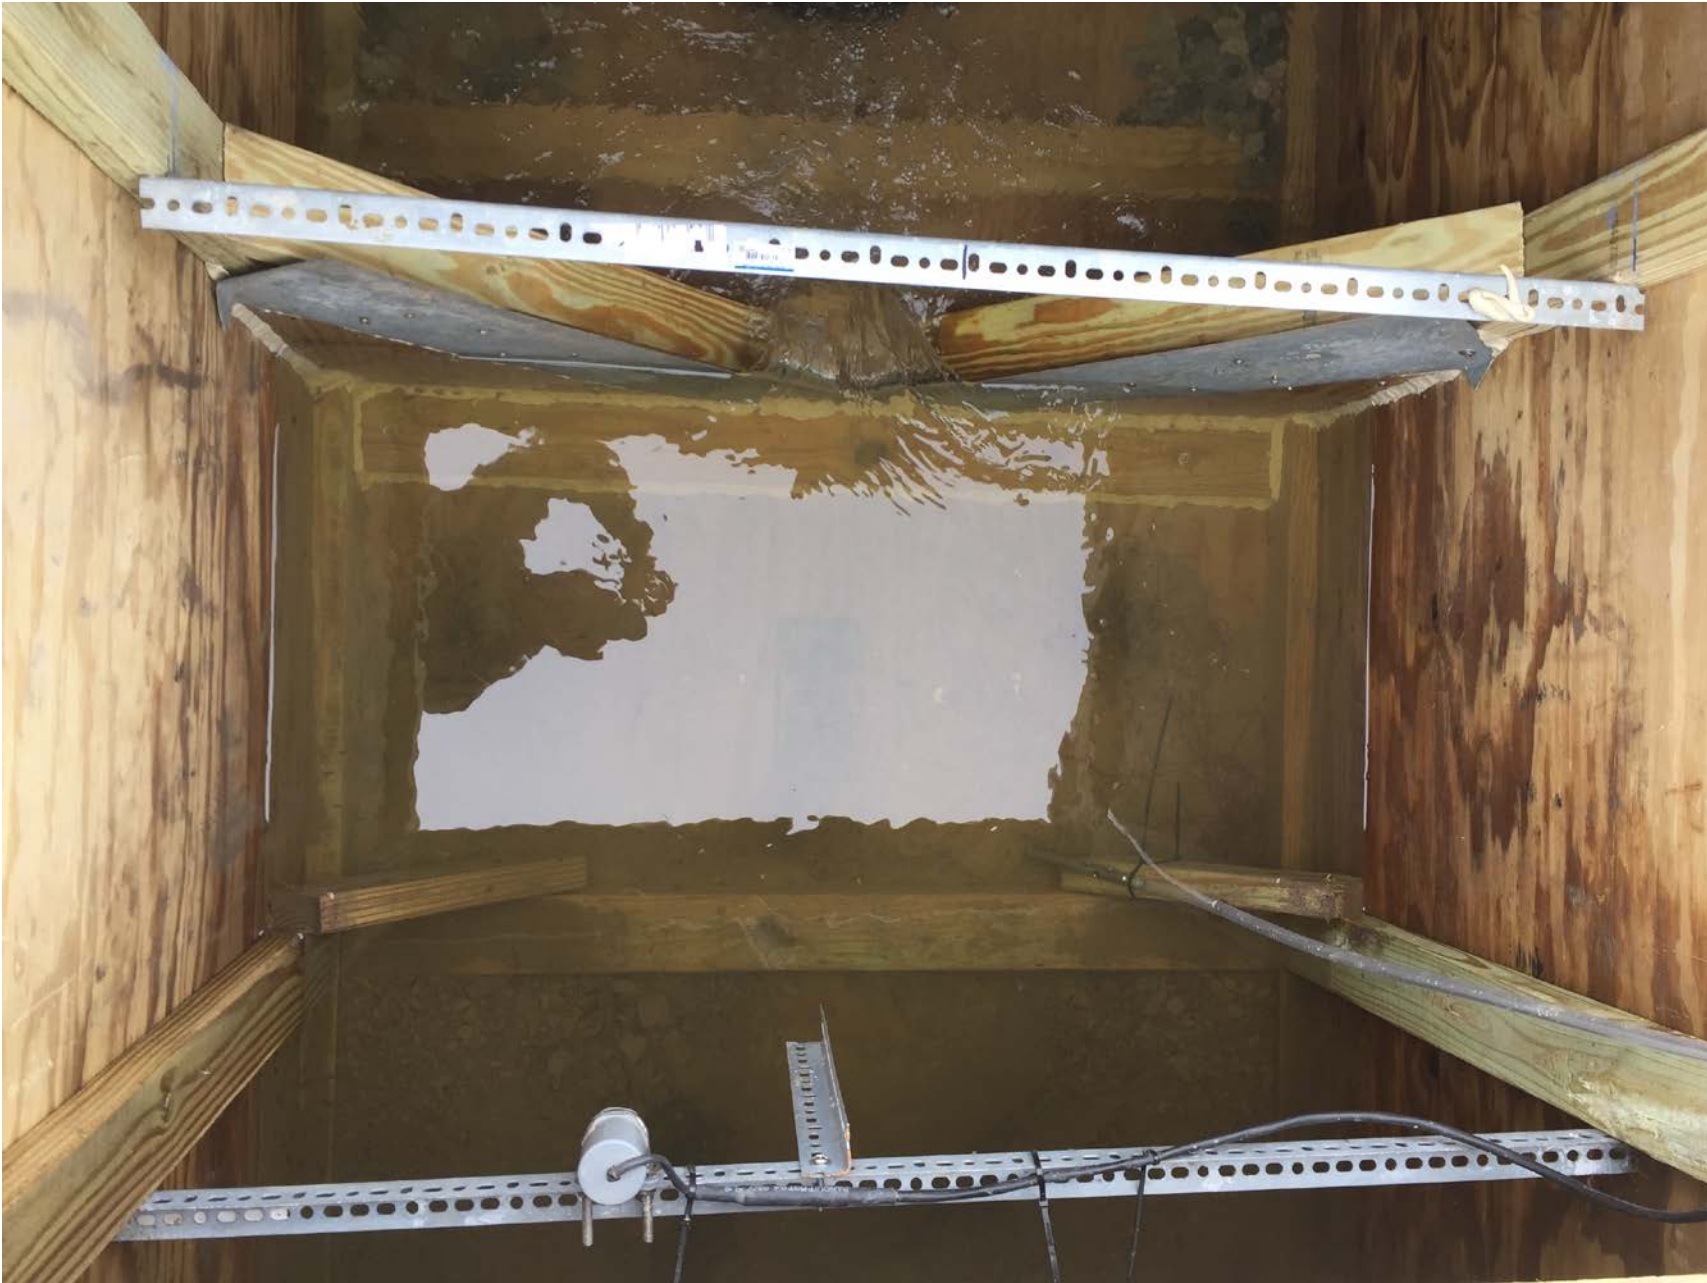
## 90-degree V Weir and Level Sensor at JBT06

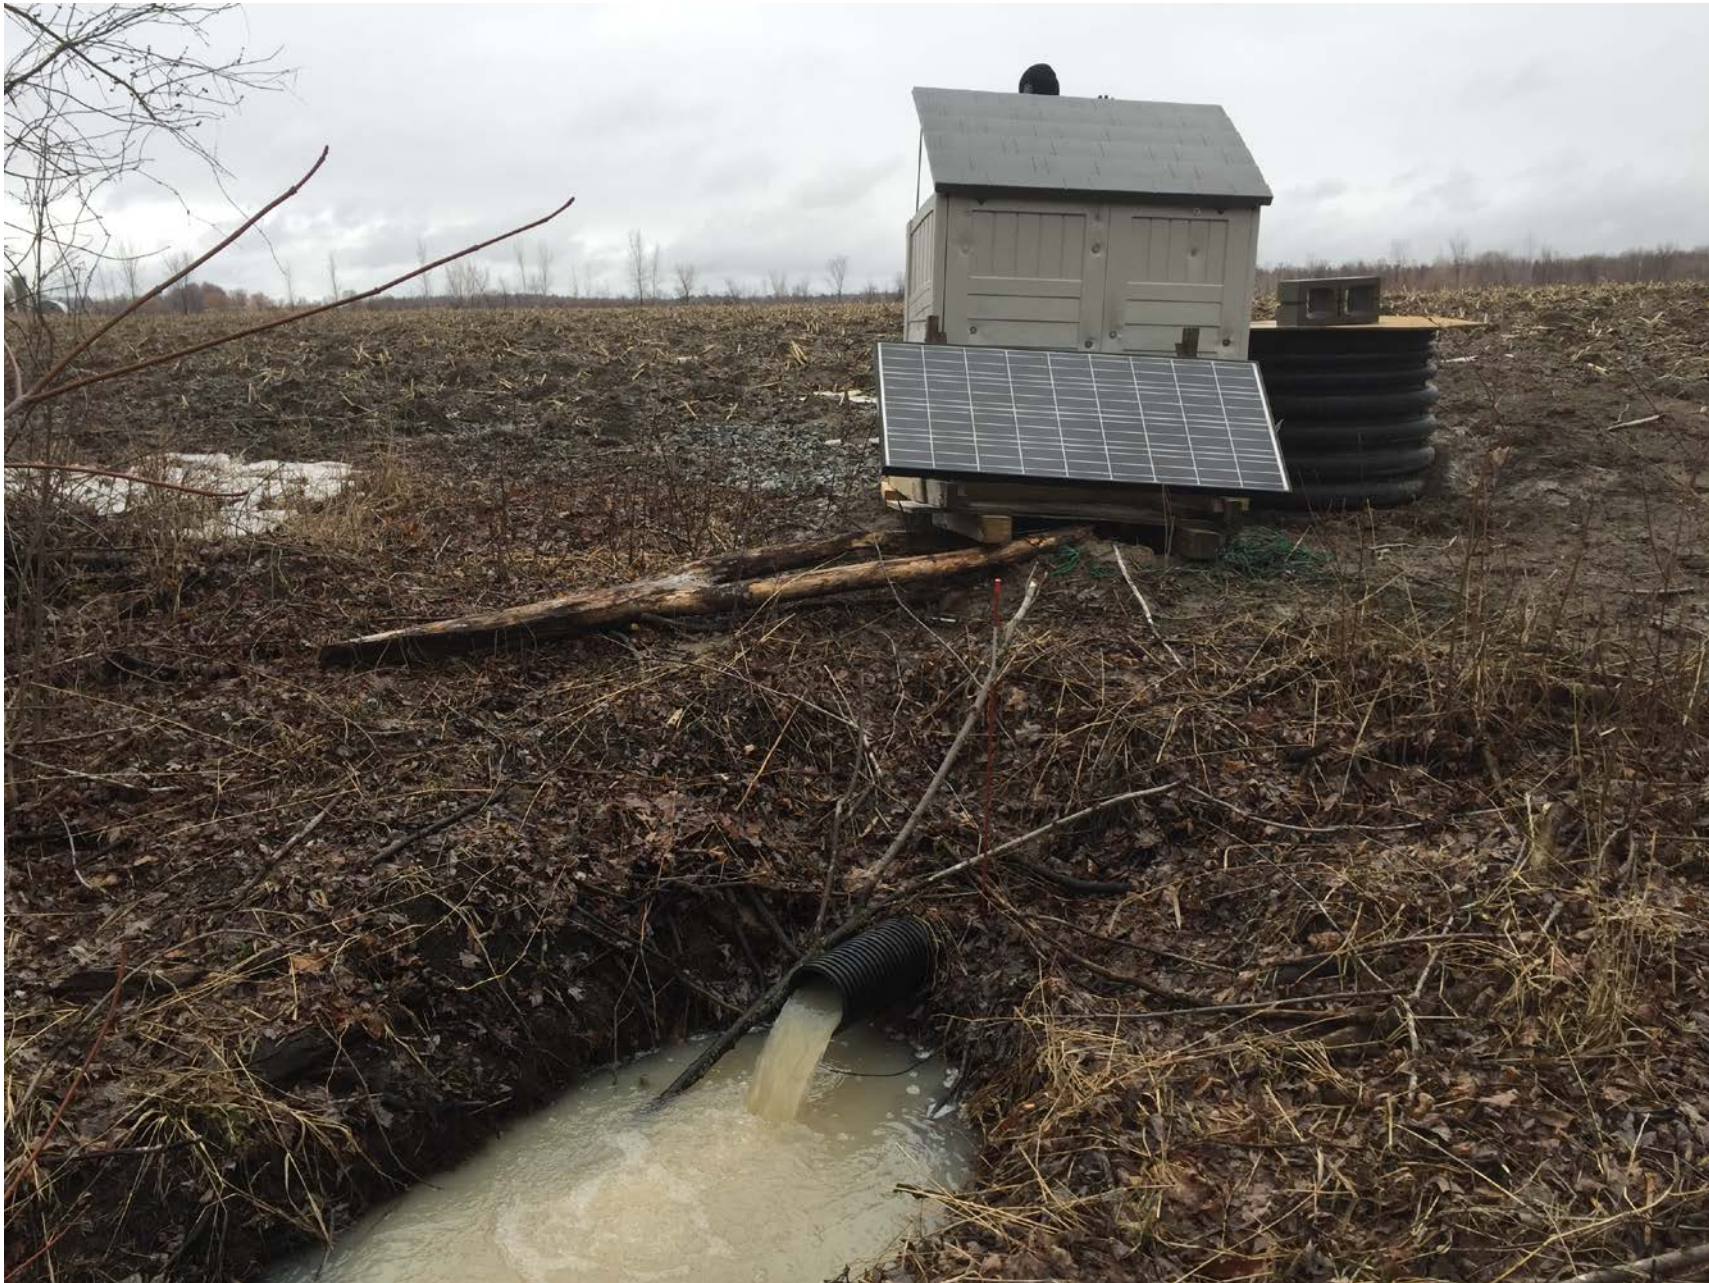
# Station JBT01

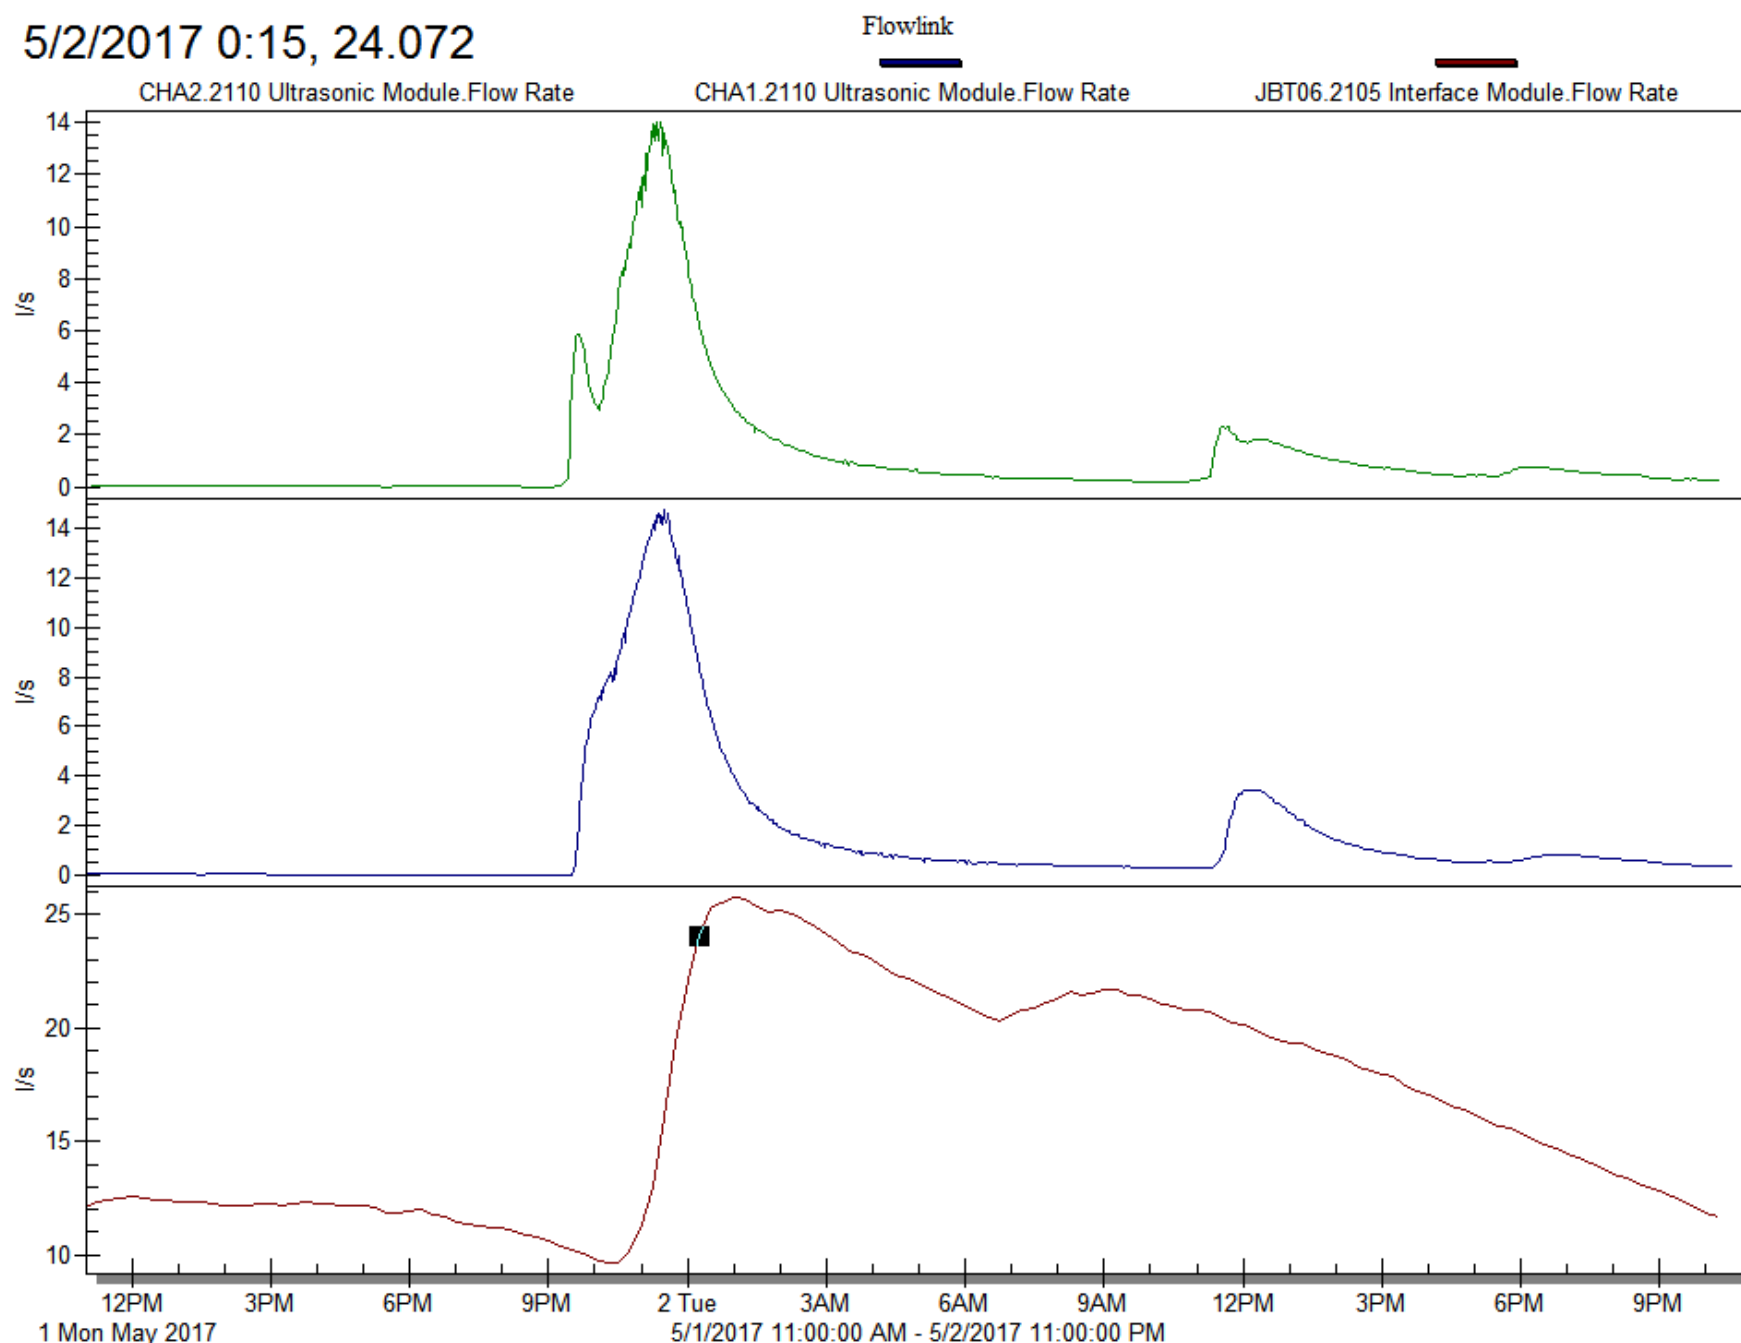
# Comparing Flow at JBT06 with CHA1 and CHA2
