# Characterization of Tile Drainage Systems in the Jewett Brook Watershed

**15-309**

**Matthew Vaughan / Technical Coordinator**  
**Lake Champlain Basin Program**  
54 West Shore Road  
Grand Isle / VT 05458  
[mvaughan@lcbp.org](mailto:mvaughan@lcbp.org)  
802-372-0216

**Dave Braun / Senior Water Resources Scientist**  
**Stone Environmental, Inc.**  
535 Stone Cutters Way  
Montpelier / VT 05602  
[dbraun@stone-env.com](mailto:dbraun@stone-env.com)  
802-272-8819

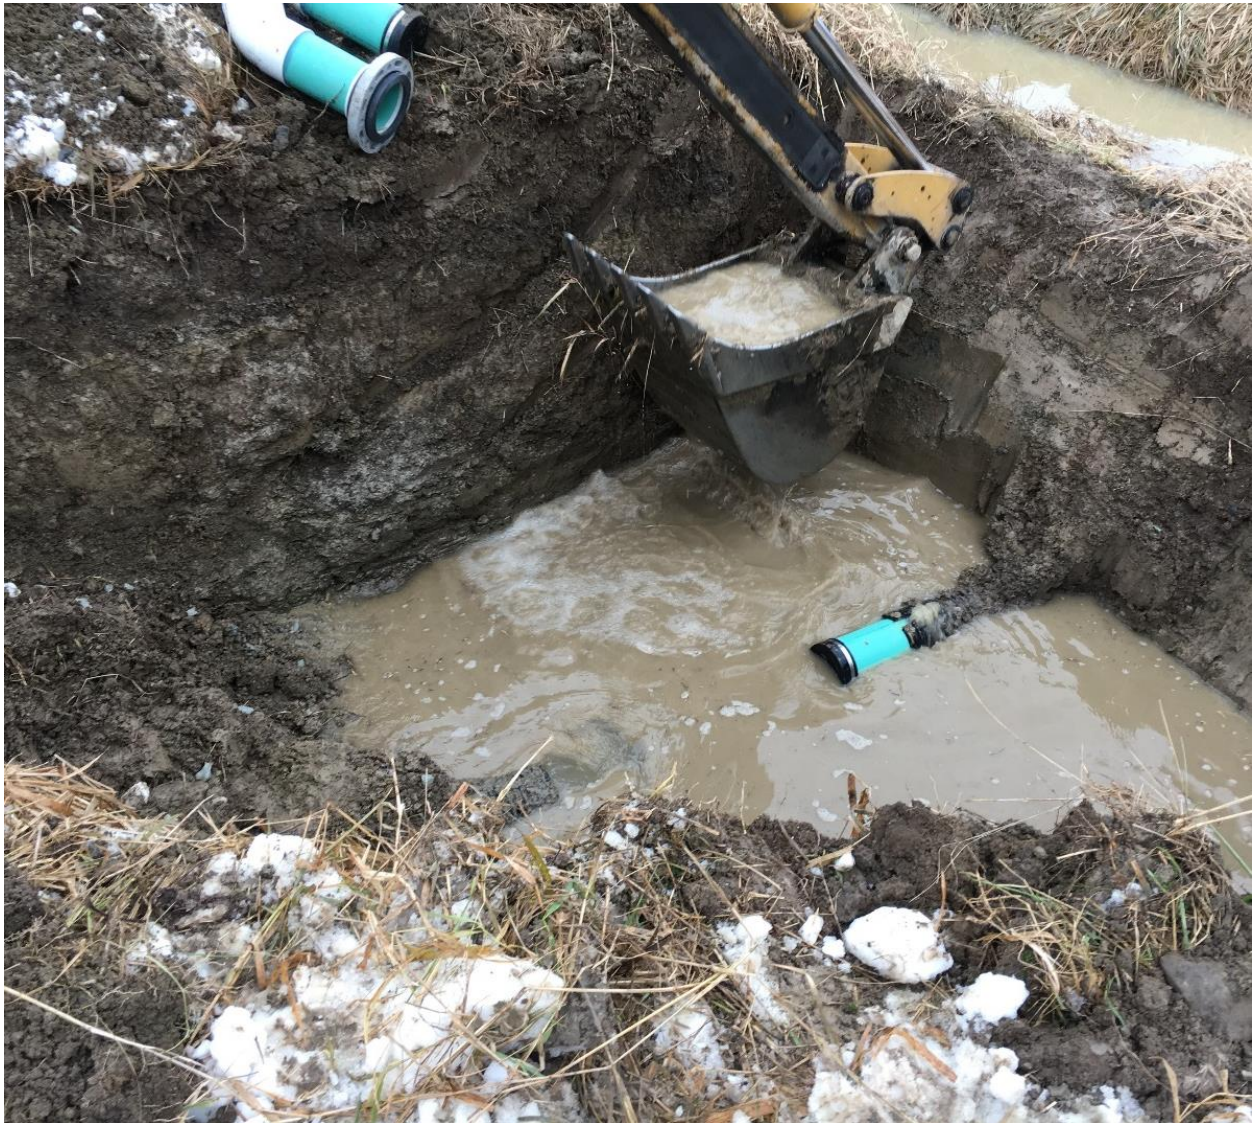
*Cover Photo:  
Installing a pipe  
trap and monitoring  
manhole at the end  
of one of the tile  
drains to be  
monitored.*

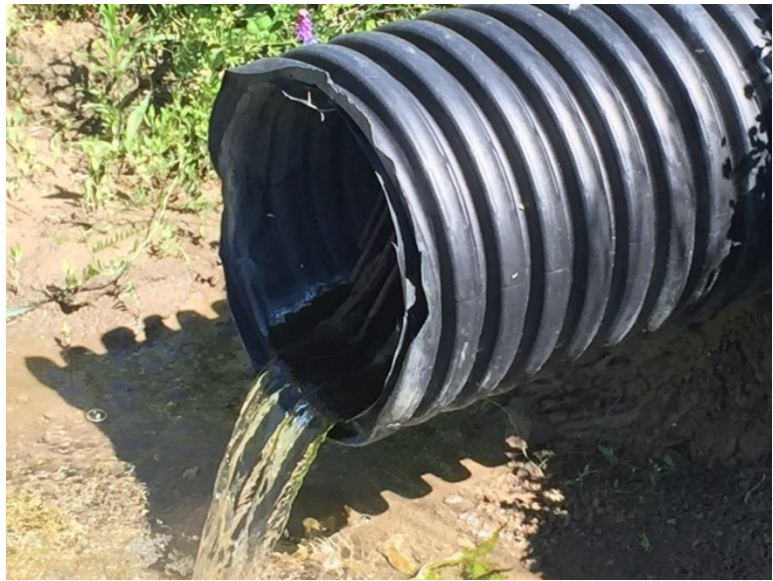
*Figure 1. JBT06 Outfall (12-inch diameter)*

systems range in diameter from 4–12 inches; there are four 4-inch, four 6-inch, three 8-inch, and one 12-inch diameter outfalls (Figure 1). Nine of the 12 tile drains discharge to drainage ditches, generally close to the bottom of the ditch such that submergence is common. The remaining three, JBT01, JBT02 (Figure 2), and JBT04, drain contiguous fields and discharge directly to Jewett Brook. The depths of the tile drains generally range from 3–5 feet below ground surface, with most in the 3–4 foot range. There do not appear to be any exceptionally shallow or deep tile drains. All but one of the study fields has patterned tile drainage. Only JBT16 has a dendritic (branching) system. Drain spacing among the patterned tile

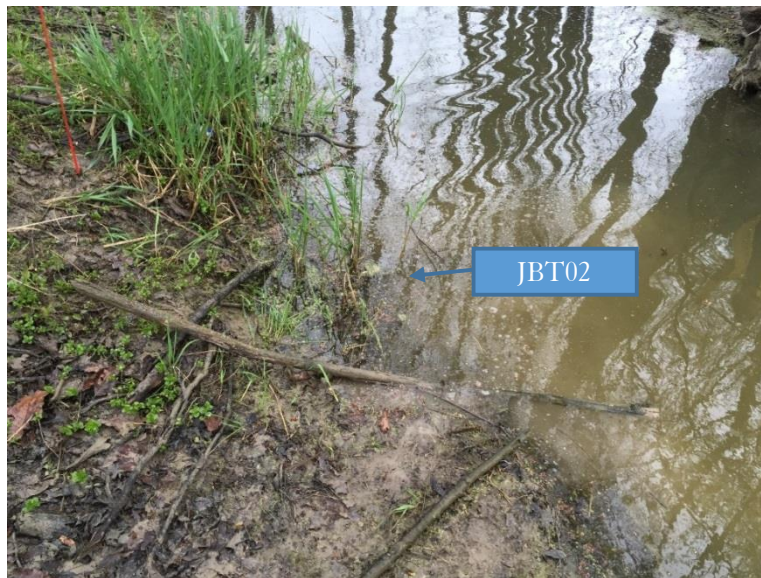
*Figure 2. Submerged Outlet of JBT02 Discharging Directly to Jewett Brook*
